Town of Bristol, CT

Space Needs Analysis Report (Partial)

Bristol Municipal Buildings

April 2012

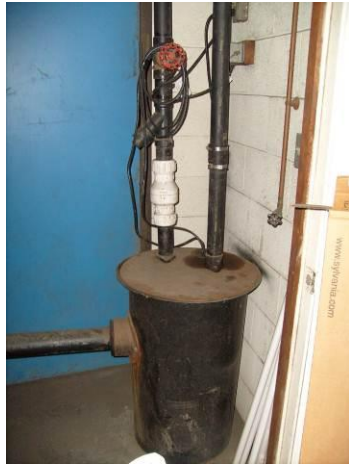
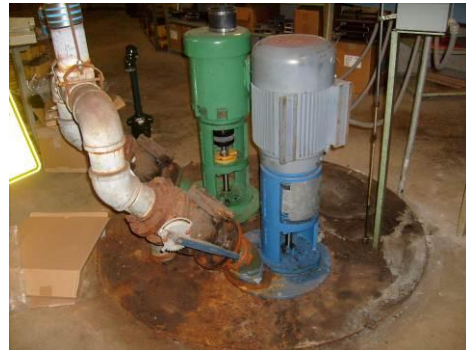
- a. The sanitary sewer system provides sanitary waste drainage for plumbing fixtures located throughout the building. The piping material above grade is primarily cast iron. The plumbing fixtures drain to buried sanitary waste piping to the buildings exterior and to the municipal sewer system. In the lower level of the Police building, sewage ejector pumps are installed to pump the waste into the municipal sewer system. These pumps are in poor condition.

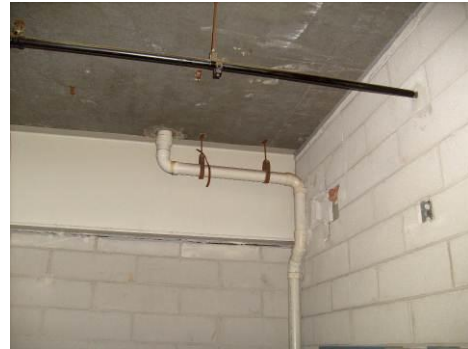
- a. The storm piping is primarily cast iron and drains to the municipal storm water system. Some of the original piping has been replaced with PVC piping. There are no secondary roof drains or strainers on the existing roof drains. Domed strainers should be added to the roof drains to keep debris out of the storm water system.

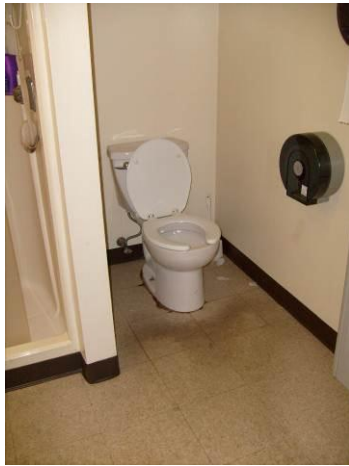
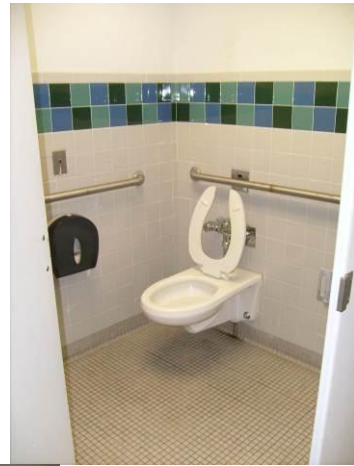
- Water closets are floor or wall mounted; flush valve, vitreous china. Some of the fixtures have been replaced with water conserving fixtures with sensor operated flush valves. The fixtures range from original to the facility in fair condition to new in very good condition. The original fixtures are non-water conserving type and non-ADA compliant.

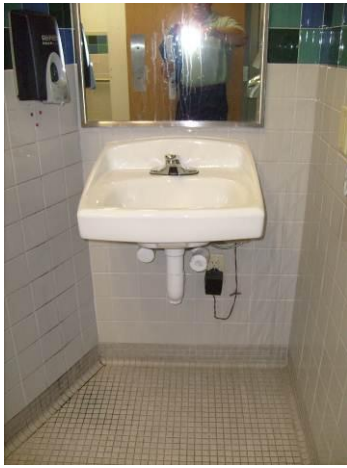
- Lavatories are wall hung vitreous china. Some of the fixtures have been replaced with water conserving fixtures with sensor operated faucets. The original fixtures have two lever handle faucets. The fixtures range from original to the facility in fair condition to new in very good condition. The original fixtures are non-water conserving type and the faucets and drains are non-ADA compliant.

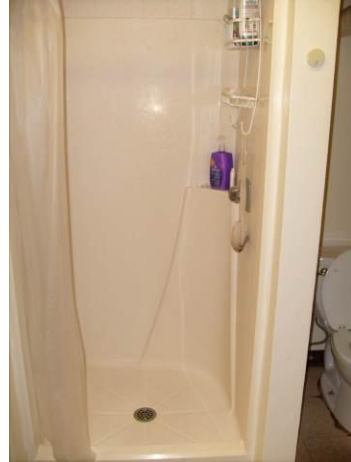
- In the Police Headquarters, there is a single shower located in the lower level training room, up a small flight of stairs. This shower is a fiberglass unit and in good condition. The location of this shower is not ADA accessible.

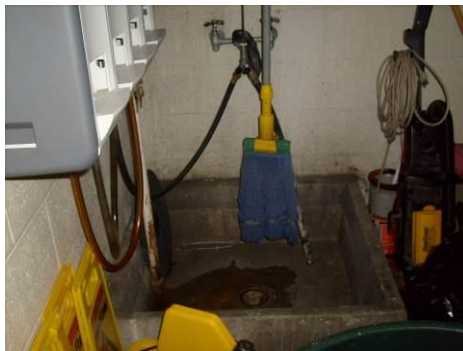
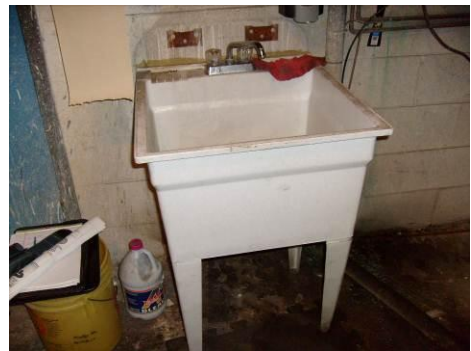
- Janitor sinks are floor mounted cast stone units with two lever faucets or pedestal mounted fiberglass units with two lever faucets. There is no vacuum breaker present at these sinks. The sinks are in fair to good condition.

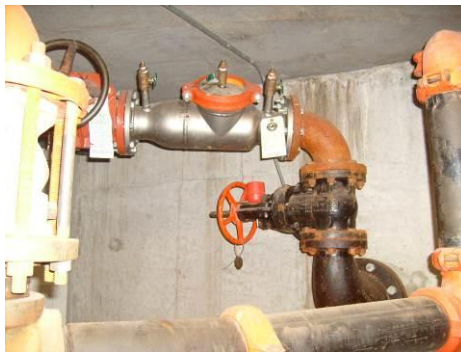
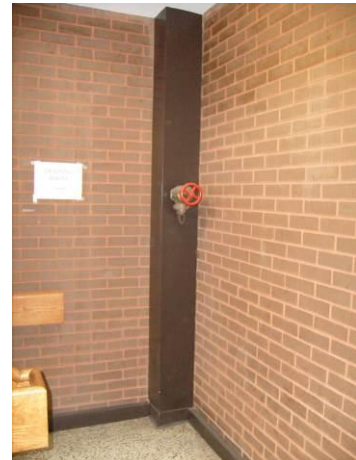
1. The building is served by a 6" fire protection service fed from a fire main in North Main Street. This fire service includes a shut-off valve and Watts Model 774 double check valve. The buildings are protected throughout with a full sprinkler system. There are also standpipes located in the stairs. This backflow preventer equipment has been recently installed and is in good condition. The remainder of the piping and most of the sprinkler heads are original to the building. The sprinkler heads and fire protection piping in the Police Headquarters was modified during the last renovation.

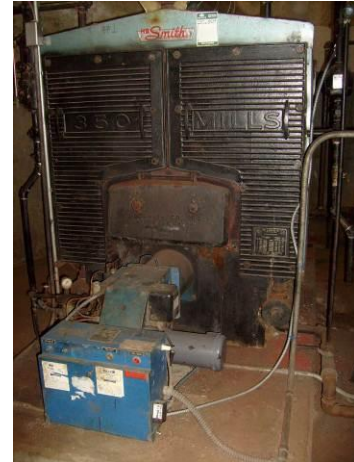
1. The existing building is heated by (2) H.B. Smith 350 Mills, 13-section oil fired steam boilers with Power Flame Model C30-04HBS-10-14 oil burners. There is a separate oil fired boiler that serves the cell block area. It is a Weil McClain Series 78, Model 478 hot water boiler with a Carlin Model 201 CRD-w oil burner. The H.B. Smith boilers, burners, and breeching are original to the building and in poor condition. The Weil McClain equipment is newer and in good condition.

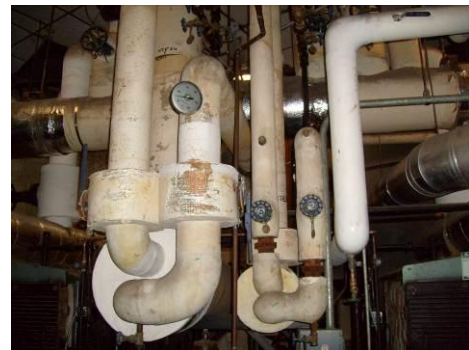
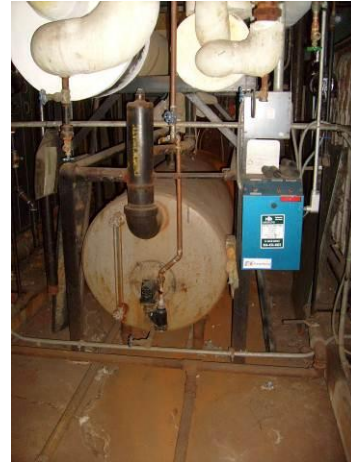
2. The heating plant also includes a condensate receiver, boiler feed system, hot water heat exchanger, condensate receivers, and hot water pumps. All of this equipment is original to the facility and poor condition.

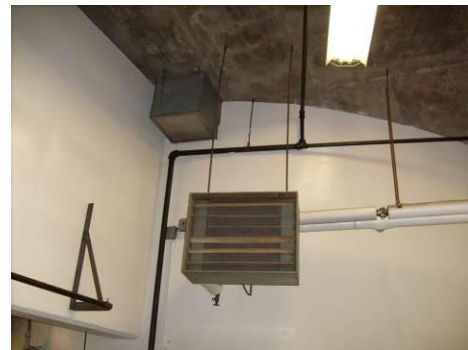
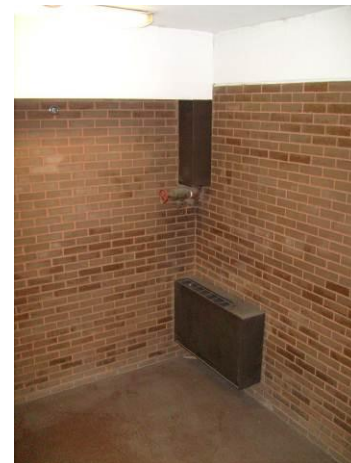
3. The present heating system also includes cabinet unit heaters, and ceiling mounted unit heaters and steam coils in the air handling equipment. This equipment is original to the building and in poor condition.

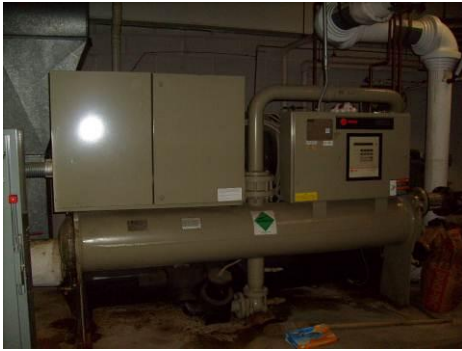
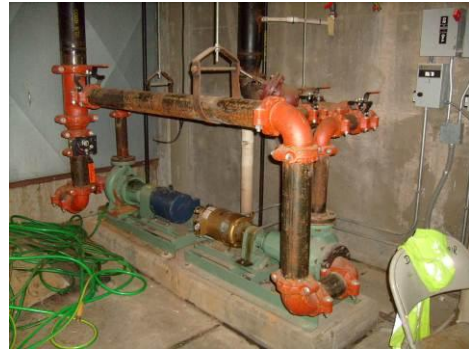
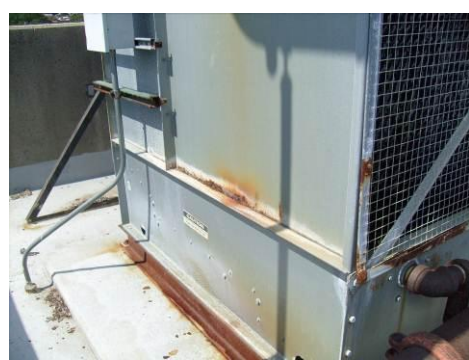
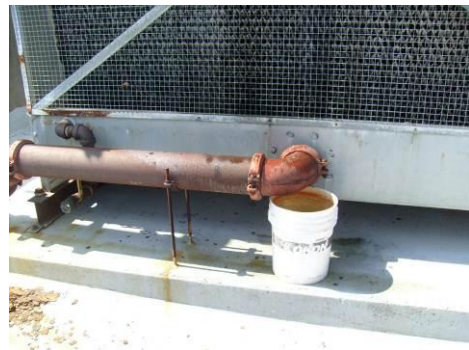
4. The air conditioning system consists of a Trane Series R Centravac chiller, Model RTHB150FMCOONW0000UNN3LF2LF00QU chiller installed in 1996. This chiller is shared between the two buildings. The chiller is in good condition. There is a cooling tower mounted on the roof of the parking facility that is in very poor condition. This piece of equipment has significant corrosion problems and the maintenance staff has made many attempts to repair this sump which has allowed this unit to operate.

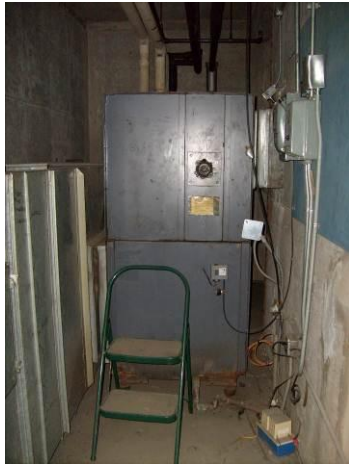
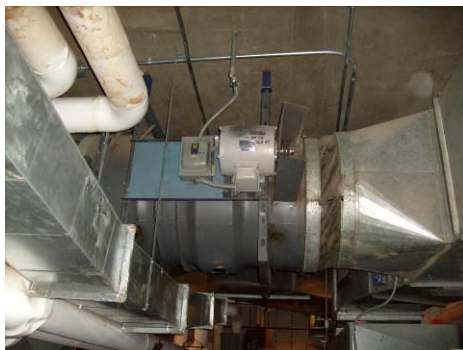
5. The air handling equipment is Trane Climate Changer units that serve as heating and air conditioning units or air conditioning units only. There are also large exhaust/return air fans. This equipment is located in mechanical rooms within the buildings and are original to the facility and in poor condition.

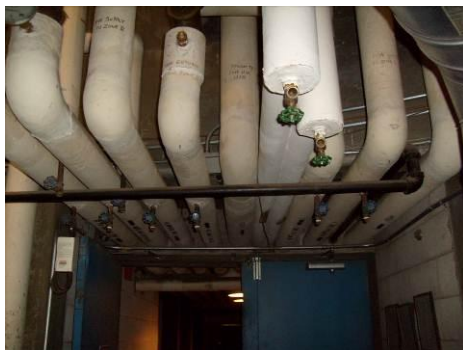
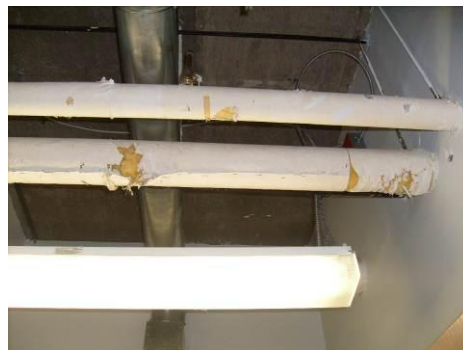
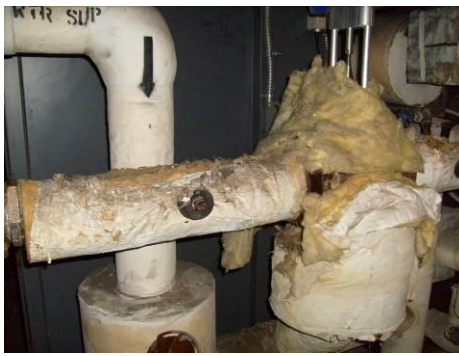
6. The steam and chilled water piping consists of iron supply and return piping. This piping is original to the facility and the steam condensate piping is more than likely in poor condition. There are a number of areas where the pipe insulation has been damaged and should be repaired.

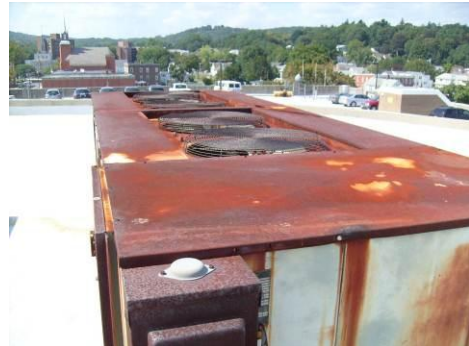
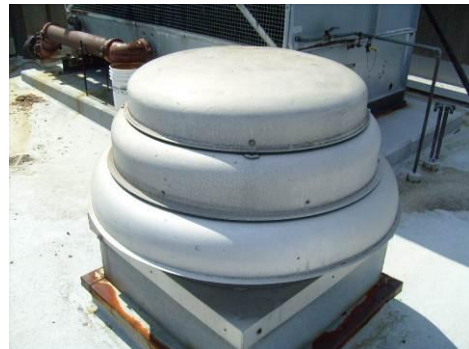
7. The roof mounted equipment consists of exhaust fans, condensing units, etc. This equipment is original to the building and in poor condition.

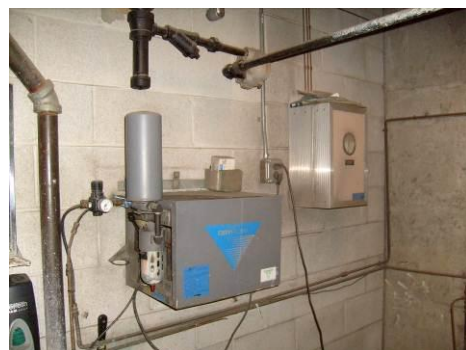
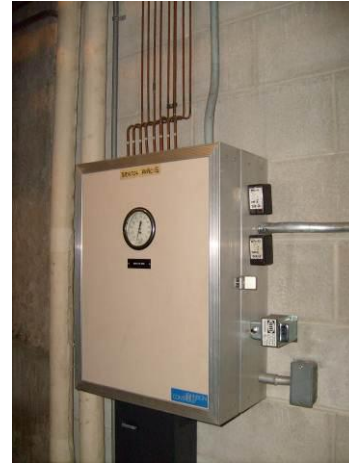
8. The existing temperature control system consists of a pneumatic system by Johnson Controls. This includes an air compressor, air dryer, control panels and pneumatic tubing. Some of the control valves have been replaced as needed. The remainder of the equipment is original to the building and in poor condition.

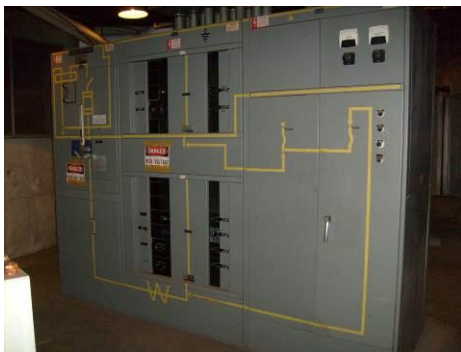
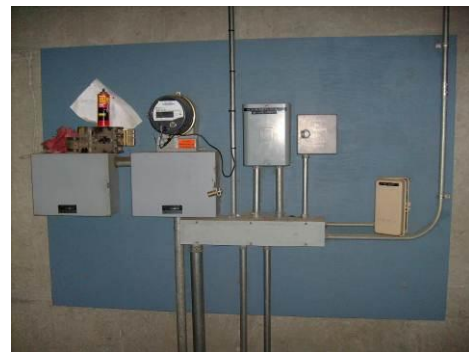
1. The building is served by a single electrical service rated 1600amperes, 480Y/277volts, 3-phase, 4-wire. This service equipment consists of a 1600amp main disconnect switch, distribution sections and metering per utility company requirements. The service equipment is original to the building and is in fair condition. In addition, the current electrical room access does not meet the current code requirements for egress from the room.

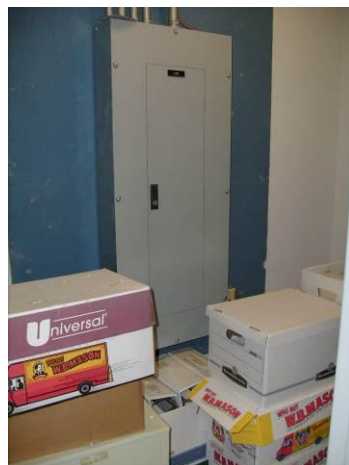
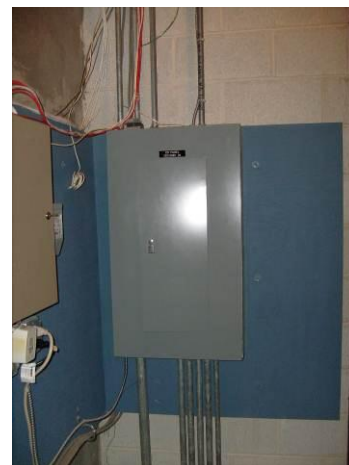
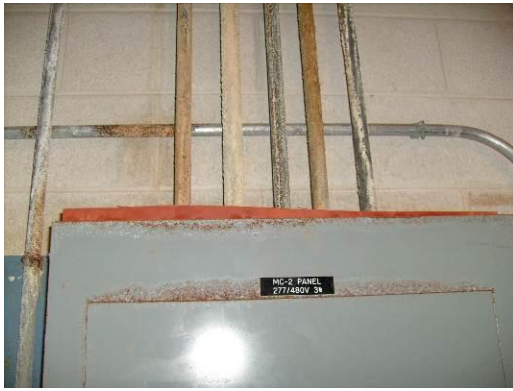
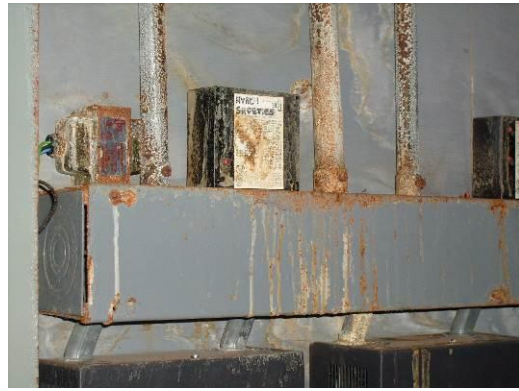
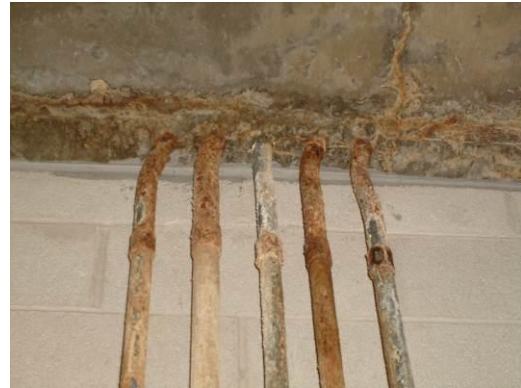
2. There are a number of electrical panels located throughout the facility. Some of these panels are original to the facility and some have been replaced with new. There are a number of panelboards located in storage rooms that have material stored in front of them which is a code violation. In addition, there is one panelboard that has had a significant water leak above it. The conduit, boxes, and panel are showing signs of corrosion. The condition of the panelboards ranges from poor to good.

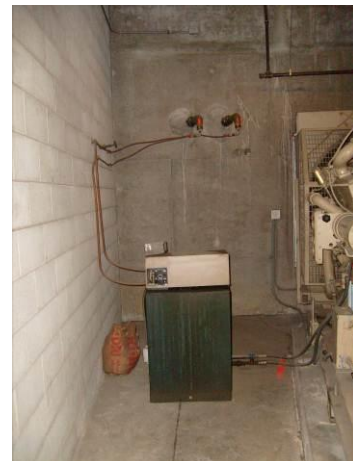
3. The building is served by a Cummings Model 080FDR5057A8W, 410kW, 613kVA diesel generator. The generator is located in the main electrical room. The transfer switch is located in the main electrical switchboard. There is a separate day tank (fuel tank) that pumps fuel oil from the exterior underground tank to feed the emergency generator. To meet current codes, (2) separate automatic transfer switches would be required to separate life safety from other loads in the building. This generator and associated equipment is original to the facility and in good condition.

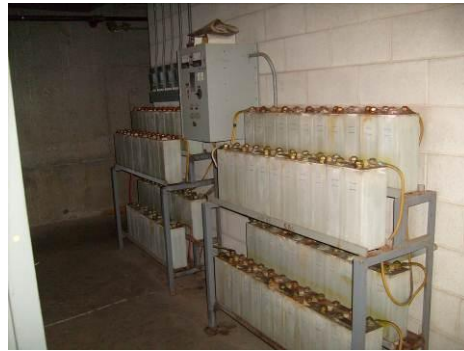
4. In the Main Electrical Room there is a series of (91) wet-cell batteries that serve as back-up power to emergency lighting and other pieces of equipment between when normal utility power is lost and the emergency generator starts. It is controlled by a Dual

Lite Model 120-120-S-791 charger. There is also a number of Dual Lite control panels located throughout the building. Some of these control panels are inaccessible because of items stored in front of them. This equipment is original to the facility and in fair condition. To satisfy current codes, this equipment is required to be in a separate room with adequate ventilation, etc.

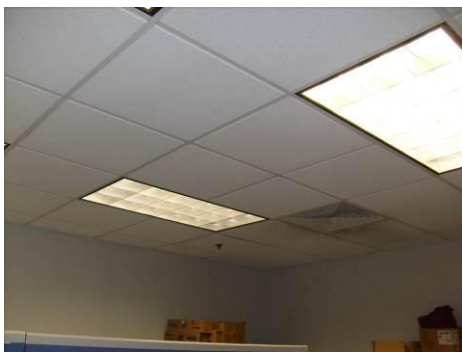
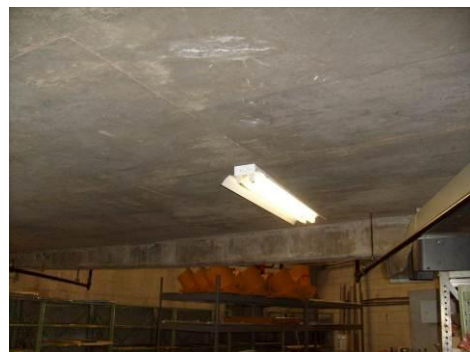
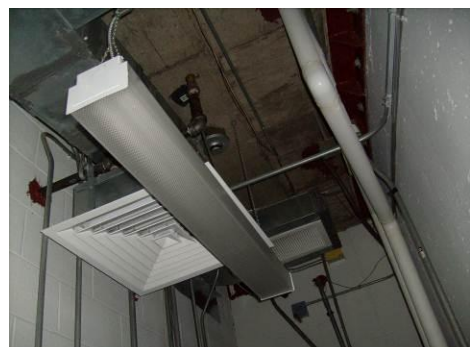
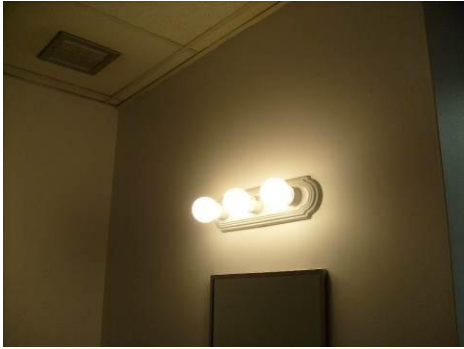
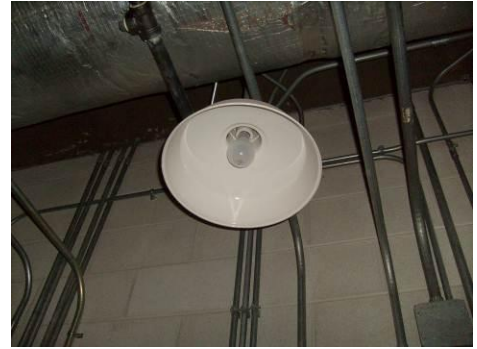
5. The lighting throughout the facility consists of recessed parabolic fixtures, recessed center basket fluorescent fixtures, and recessed mounted acrylic lensed fluorescent fixtures in the office areas, etc. Other fixtures include industrial fluorescent fixtures, wrap around acrylic lensed fixtures, and other miscellaneous fixtures throughout the building. Most of the lighting has been upgraded to newer T8 technology, however, there are other fixtures using older T12 technology or incandescent lamps. The lighting ranges from very good to poor condition.

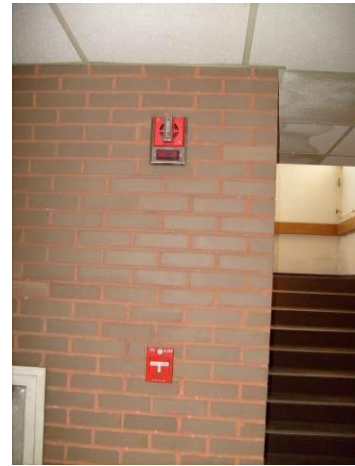
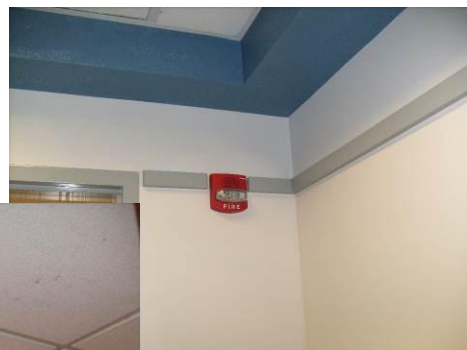
6. The fire alarm system is manufactured by Fire Lite, Model Sensiscan 2000 or Simplex. The system includes control panels, manual pull stations, horn-strobes, and some smoke detectors. This system is in fair condition and portions are non-ADA compliant. Additional audio visual devices should be added to the building as well as upgrading to an addressable ADA-compliant system.

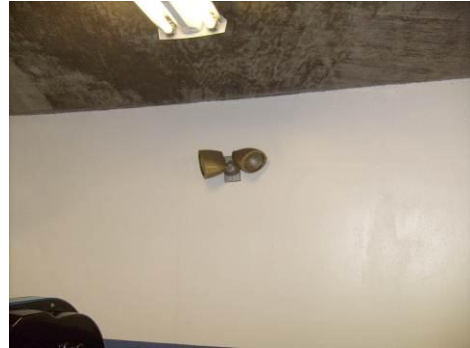
7. The emergency lighting is provided by a Dual Lite Inverter System that includes the inverter, batteries, ceiling mounted remote heads and controls. Although this system is operational, it is in poor condition. Additional lighting fixtures are required to meet current requirements for emergency lighting.

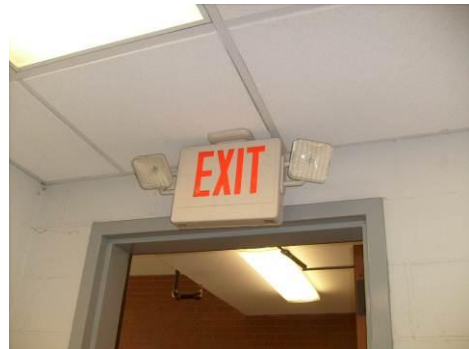
8. The exit signs consist of fluorescent exit signs with batteries. This equipment is in fair condition. Additional exit signs are required to meet current requirements for exit signs.

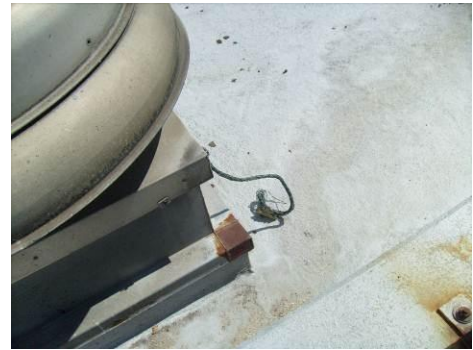
- a. There is a lightning protection system installed at the facility. It appears that during recent roof work, some of the lightning protection system was disconnected. This should be repaired to maintain the integrity and operation of the system.

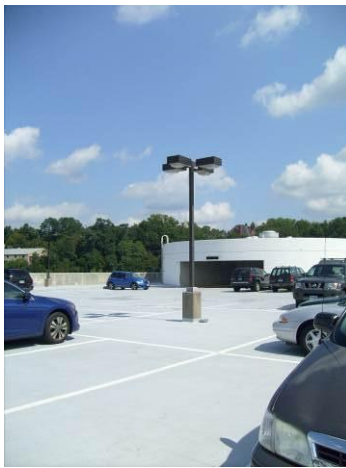
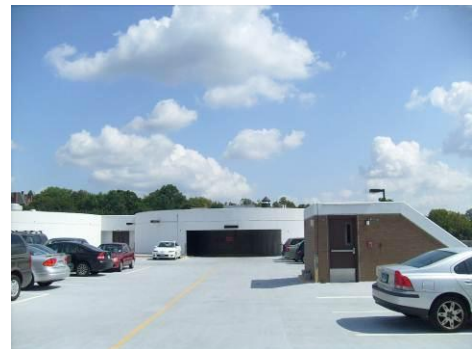
- b. There is a site lighting system on the top level of the parking garage. This lighting system serves the parking areas only and includes pole and wall mounted fixtures. This equipment is in fair condition.

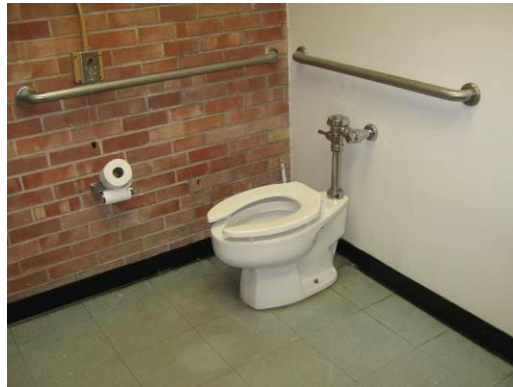
- Water closets are floor or wall mounted; flush valve, vitreous china. These fixtures are non-water conserving type in fair condition. Most of these fixtures are non-ADA compliant.

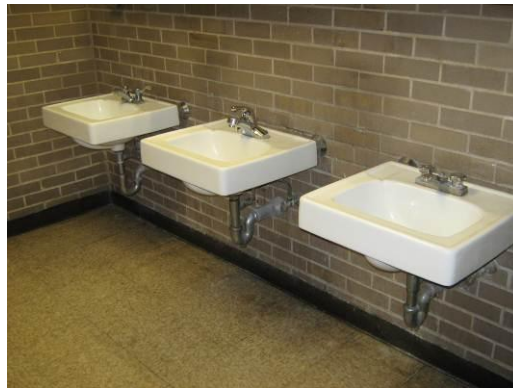
- Lavatories are wall hung vitreous china. Faucets are a combination of single lever handle and two lever handle faucets. The lavatories are in fair condition. The faucets and drains are non-ADA compliant.

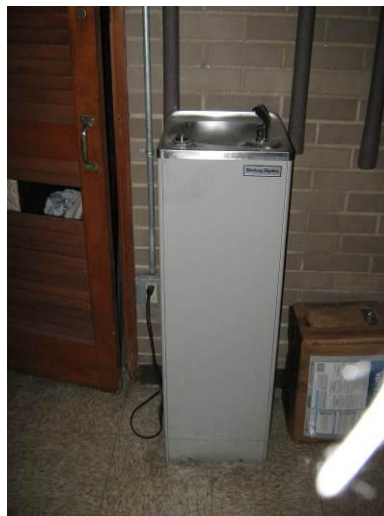
- Drinking fountains are floor mounted steel units, non-ADA compliant and in fair condition.

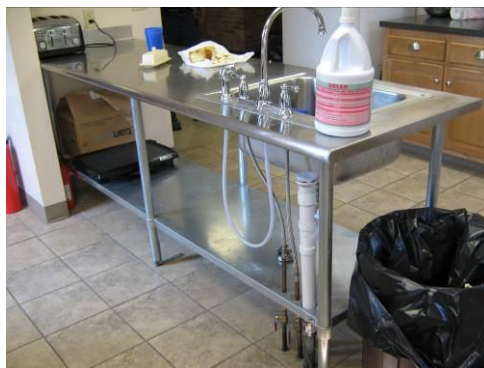
- A stainless steel sink with two lever gooseneck type faucet and spray hose has recently been added to the kitchen. This sink is non-ADA compliant and in good condition.

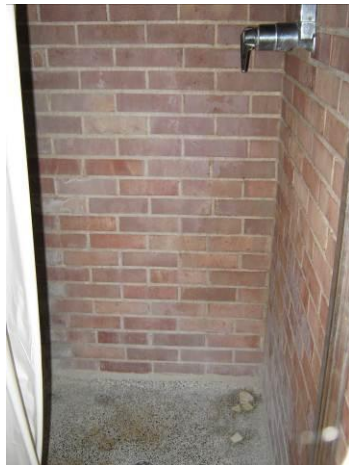
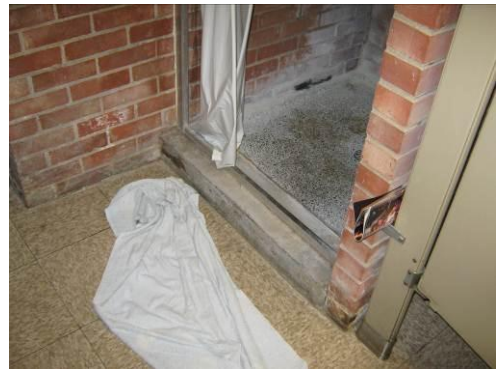
- The showers are constructed of brick with terrazzo type bases. The showers have single lever operators. These showers are non-ADA compliant and in poor condition.

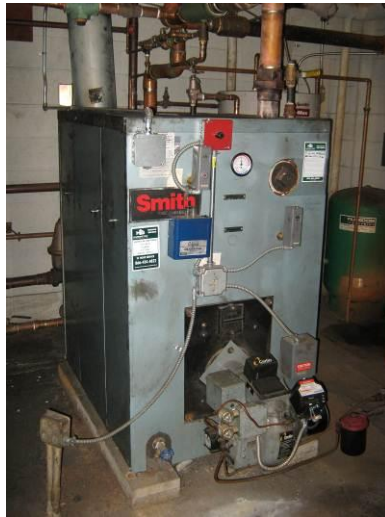
1. The existing building is heated by a single H.B. Smith oil fired hot water boiler. The oil burner is a Carlin Model 702 CRD. The boiler is in fair condition. The oil burner is in good condition.

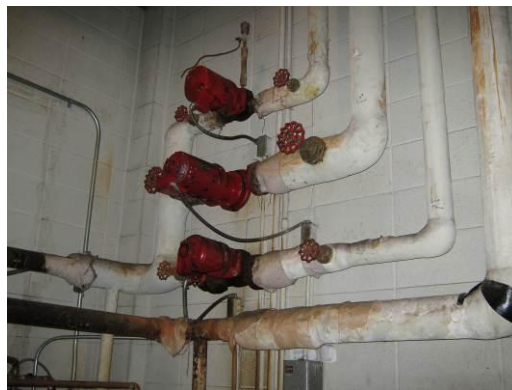
2. There are (3) zones for the heating hot water. Three (3) in-line circulator pumps push water to the three zones. These hot water pumps are in poor condition.

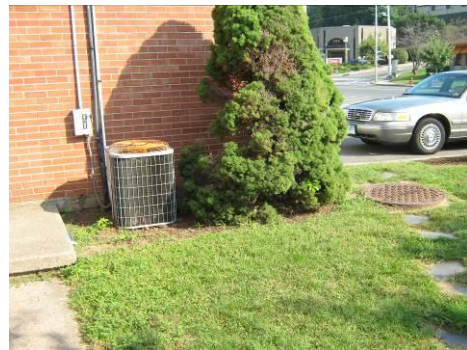
4. There are ceiling mounted fan coil units with supply air ductwork, ceiling mounted supply air diffusers, a single return, and remote condensing units for air conditioning. There are complaints from the occupants because of poor air distribution from these units. This equipment is in poor condition.

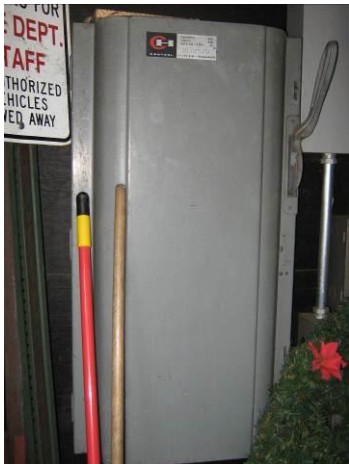
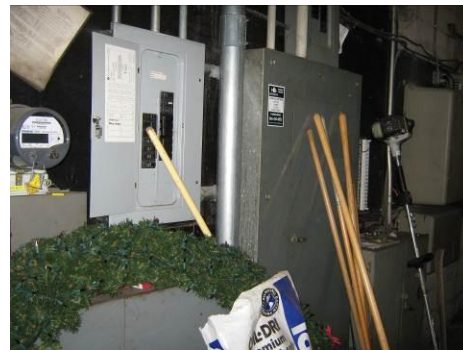
1. The building is served by a single electrical service rated 400amperes, 208Y/120volts, 3-phase, 4-wire. This service equipment consists of a 400amp main disconnect switch, panelboards and metering per utility company requirements. The service equipment is original to the building and is in fair condition.

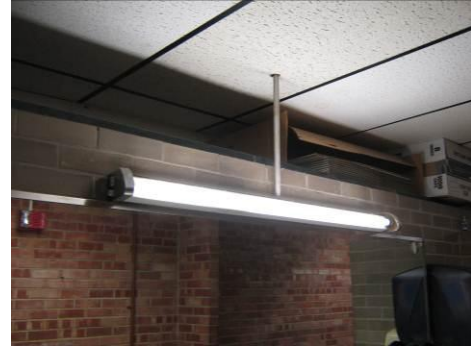
3. The lighting throughout the facility consists primarily of recessed mounted acrylic lensed fluorescent fixtures in the occupied spaces and industrial fluorescent fixtures in the apparatus bays and storage areas. There are other miscellaneous fixtures spotted throughout the building. Most of the lighting is older T12 technology and should be upgraded. There are other fixtures using incandescent lamps that are in poor condition that should be replaced. There are also other fixtures that are damaged that should be replaced. The lighting ranges from poor to fair condition.

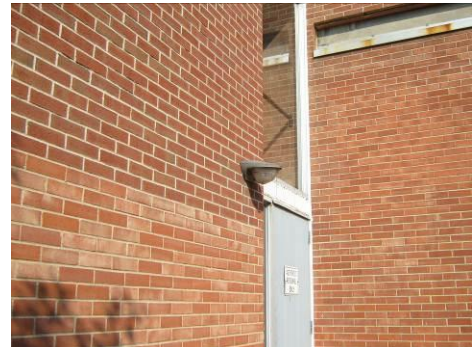
4. Site lighting is limited and consists of building mounted flood lights. These fixtures are not energy efficient and are in poor condition.

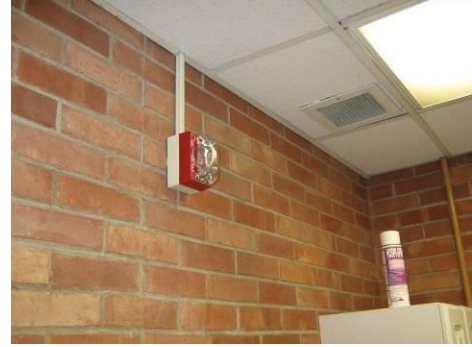
5. The fire alarm system is manufactured by Simplex, Model 4004. The system includes manual pull stations, horn strobes, and ceiling mounted smoke or heat detectors. This system is in good condition. The coverage of smoke detectors and other devices appear to be inadequate. Additional devices, such as horn/strobe units, are required to comply with current ADA requirements.
