Town of Newtown

Facilities Assessment Report

AUGUST 24, 2015

NEWTOWN FACILITIES CONDITION ASSESSMENT REPORT

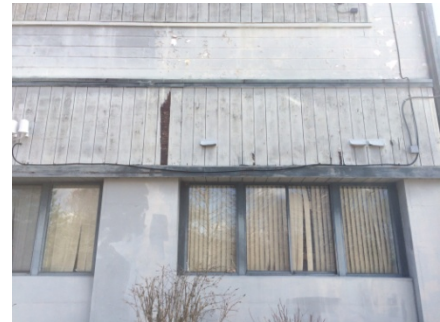
- 2 Exterior siding is deteriorating and is in need of replacement. The north and east sides of Texture 1-11 siding has been redone but the remaining two sides need to be replaced and painted.

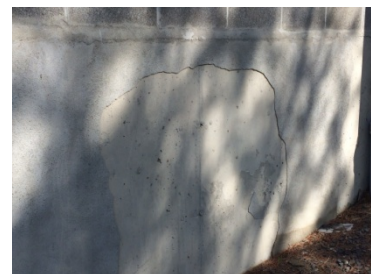
- 3 Parging is delaminating from concrete foundation wall. Remove loose material, apply bonding agent and re-parge exposed concrete areas.

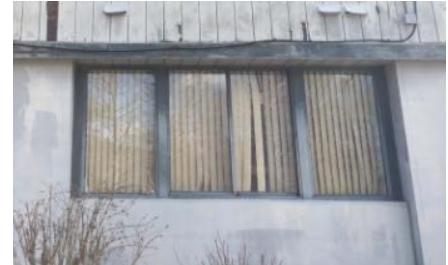
EIFS system needs to be repaired on the exterior wall adjacent to the public restrooms.

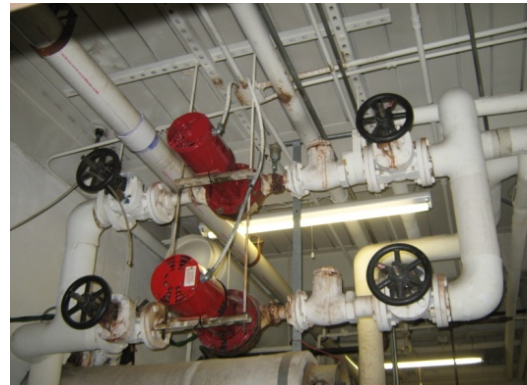
Boiler Plant: The building is heated by one Eighty Eight Series hot water boiler. The boiler is gas fired and reaching the end of its useful life. There are two pumps which provide redundancy in case one pump fails. The hot water system serves fin tube radiation and duct mound hot water coils. The hot water pumps are controlled by six temperature zones via electric relays. Recommend replacing the boiler with two high efficiency condensing boilers to provide redundancy and higher levels of energy efficiency (up to 95% versus current boilers with nominal efficiency of probably 75% to 80%). Replace hot water distribution and controls to provide more zones for energy efficiency and update controls to DDC type system.

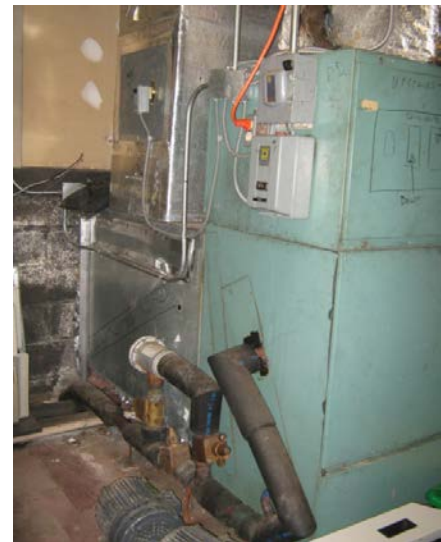
Most of the building is served by indoor mounted air handling units with remote compressor / condensers and duct mounted hot water coils. Most of the units are old are in fair to poor condition. Ductwork distribution to spaces below includes single zone hot water coils. "Local" air conditioning is also provided at specific areas with ductless split units. Temperature control system is via electric relays with electric actuated valves and dampers. Computer Operations Room needs improved air conditioning and ventilation. Recommend replacing air handling systems and replace and upgrade controls to web based DDC type system.

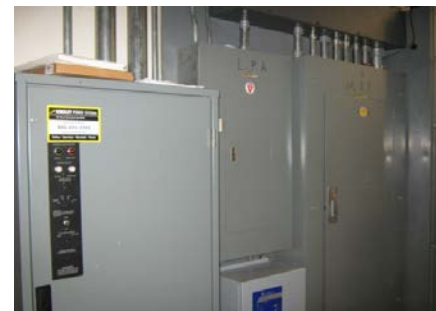
The building is served by a Square D distribution panel, rated at 400 amperes, 208Y/120 volts, 3-phase. The service equipment and main distribution panels are in good condition.

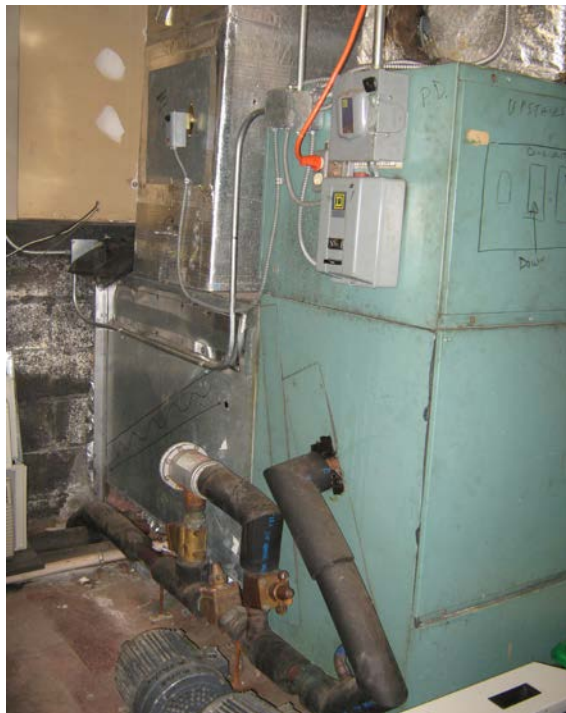
EXISTING AIR HANDLING SYSTEMS

1. Most of the building is served by indoor mounted air handling units with remote compressor / condensers and duct mounted hot water coils. Most of the units are old are in fair to poor condition.

1. Replace the boiler with two high efficiency condensing boilers to provide redundancy and higher levels of energy efficiency (up to 95% versus current boilers with nominal efficiency of probably 75% to 80%). Replace hot water distribution and controls to provide more zones for energy efficiency and update controls to DDC type system.
2. Replace air handling systems.
3. Replace and upgrade controls to web based DDC type system.

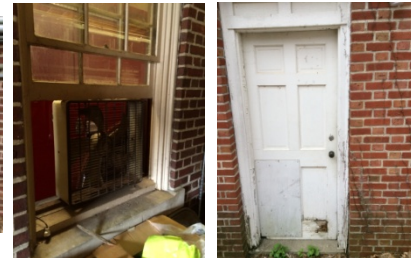
Replace exterior door from north addition.

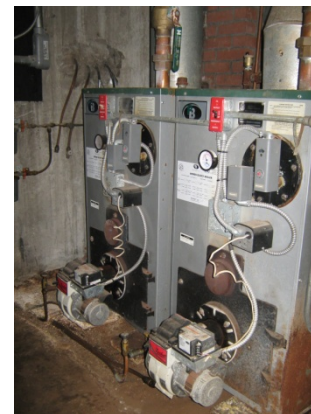
Boiler Plant: The building is heated by two (2) Peerless hot water boilers; each with nominal 350 MBH capacity. The boilers are fuel fired fed from a buried fuel oil tank outside the building. The buried fuel oil piping does not appear to be double wall. The boilers are in good condition. There are four (4) hot water pump zones controlled by local electric thermostats.

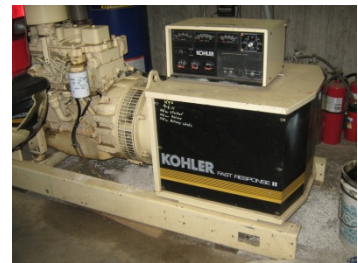
The building is served by General Electric distribution panels, service rated at 200 amperes, 208Y/120 volts, 3-phase. The service equipment and main distribution panels are in good condition. Emergency Generator: The generator is a 30 KW Kohler; fuel fired generator with day tank / pump set located inside the garage bay. The system is in fair condition.

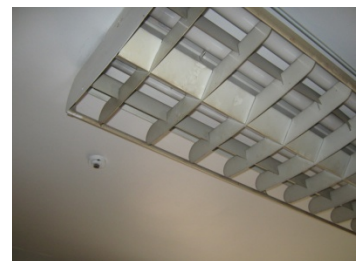
Lighting, in general, consists primarily of fixtures with T12 fluorescent lamps. Most of the fixtures are in poor condition and should be updated to more energy effacement lighting and controls. Emergency lighting is handled by an emergency generator. The fire alarm system is a FCI zoned system which is in fair condition.

Recommend upgrading Upgrade some of the electrical power distribution throughout the building with new local panels, new receptacles and wiring. Replace lighting with new energy efficient fixtures and controls such as occupancy sensors and daylight harvesting.

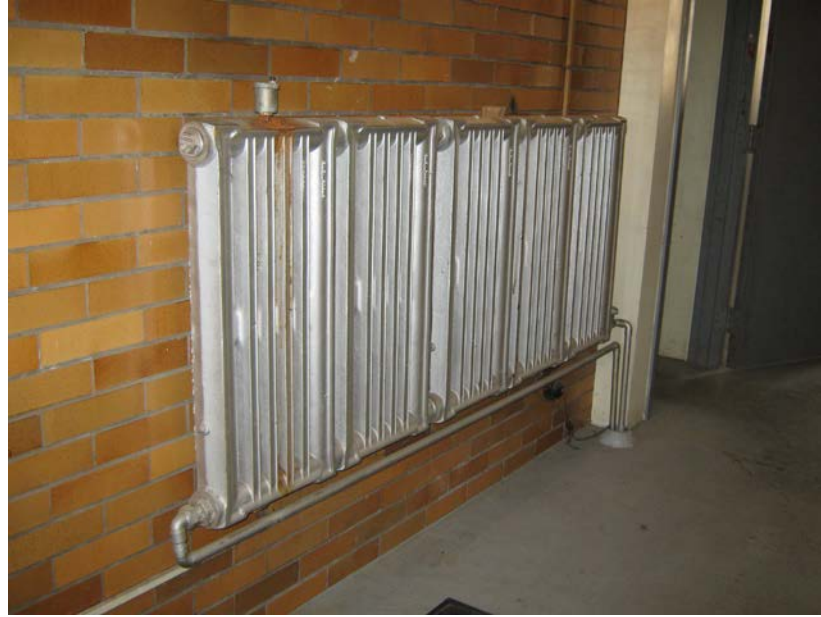
CAST IRON RADIATOR

3. The hot water system serves unit heaters and cast iron radiators. The unit heaters are in good condition, the cast iron radiators are most original to the building and nearing the end of their useful life.

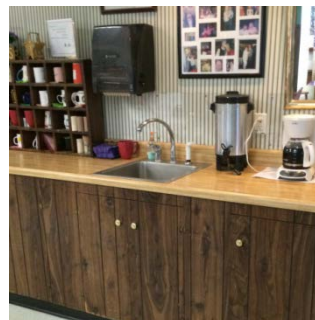
- 3 Sink and counter in Clinic and VNA Exam room (used for storage) are not ADA compliant. Change cabinets to provide knee space and replace sink.

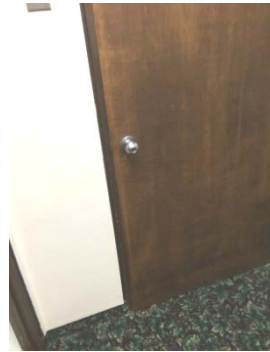
Doors throughout Senior Center building and Pre-school Area with the exception of the most recent 2010 additions (Sunroom, Workout Room and ADA restrooms) have knob sets but require lever sets for accessibility. Replace all knobsets with lever sets.

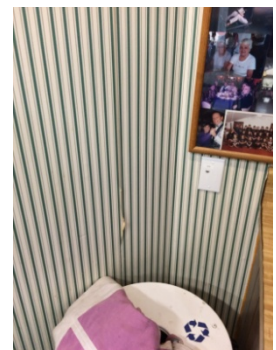
Ceiling in Multi-purpose space has multiple cracks (approx. 150 SF) Patch, repair and paint.

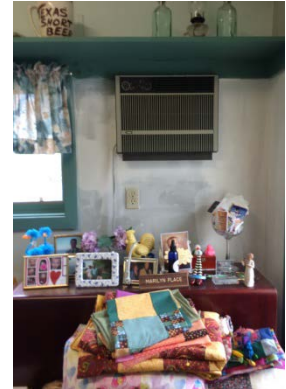
3 Walls in Directors office are in need of repainting. Repaint all walls.

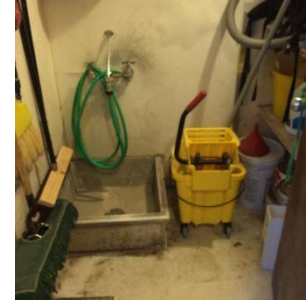
VCT in Janitors closet is dirty but in fair condition. Walls are in poor condition and need repainted. Clean or replace VCT and repaint all walls.

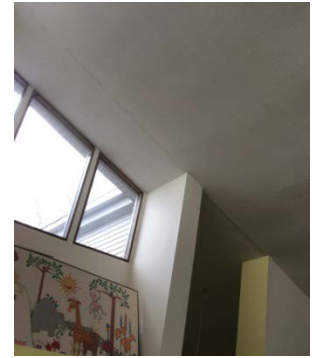
Cracks in wall in Preschool (next to window above door to back room) Repair, prime and paint.

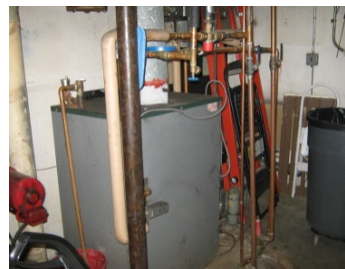
Boiler Plant: Overall, the building is heated by two separate boilers which are not interconnected. Both boilers are fuel oil fired. The boiler at the original building is a Peerless Model STC-07 hot water boiler with nominal capacity of 400 MBH. This boiler, its pumps and related hydronic piping system is reaching the end of its useful life.

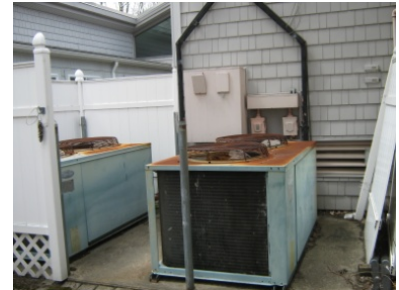
Existing Air Handling Systems: The buildings area served by indoor mounted air handling units with remote compressor / condensers located outside at grade. The two units at the original building are in fair to poor condition. The unit at the new building addition is in good conditions. The systems are fully ducted on the supply air and return air. "Local" air conditioning is also provided at specific areas with ductless split units. Temperature control is via local 7 day programmable thermostats.

Replace the air handling units and compressor / condensers serving the original building. The indoor units are located in mechanical rooms above the main floor and replacement of these units will be difficult. Also, the refrigerant piping may need to be replaced to accommodate newer types of refrigerant. Upgrade the temperature controls to provide off site monitoring through a web based program.

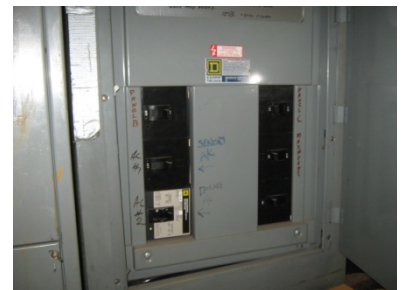
The building is served by a Square D distribution panel, rated at 400 amperes, 208Y/120 volts, 3-phase. The service equipment and main distribution panels are in good to fair condition. Recommend upgrading electrical service, local panels, receptacles and wiring at the original building.

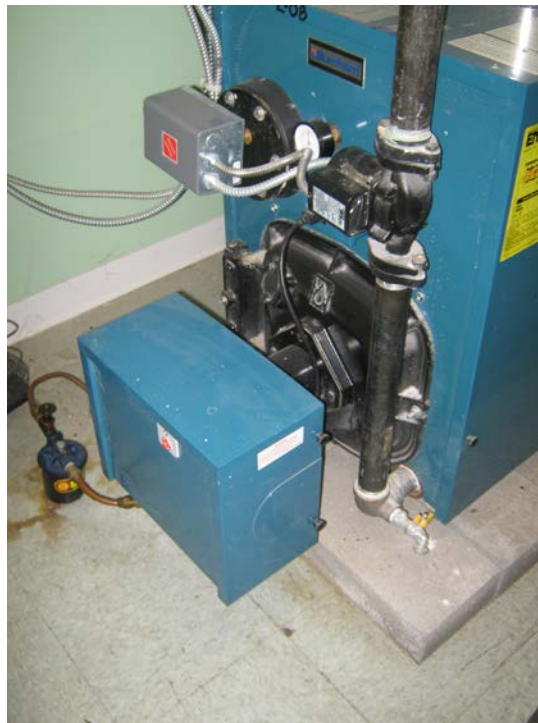
HOT WATER BOILER @ NEW BUILDING ADDITION

2. Boiler Plant: The boiler at the building addition is a Burnham Model PV85 hot water boiler with nominal capacity of 196 MBH. This boiler is in good condition
