Town of Bristol, CT

Space Needs Analysis Report (Partial)

Bristol Municipal Buildings

April 2012

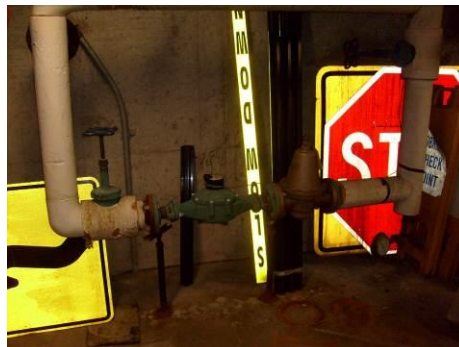
- a. Existing Domestic Water Service: The existing building is currently served by a 4 inch domestic water service. The domestic water service equipment includes a 2 inch water meter, pressure reducing valve, and isolation valves. This water service currently serves all of the building's domestic water needs and has adequate pressure. The water distribution system is original to the building.

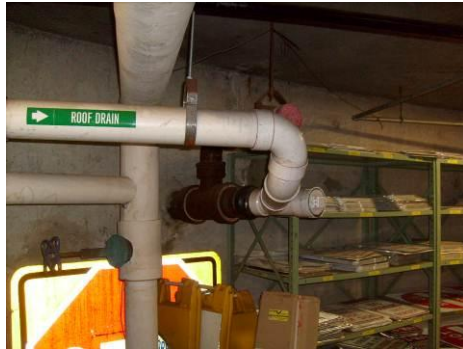
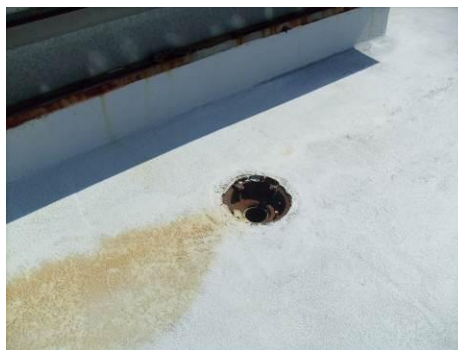
- a. The storm piping is primarily cast iron and drains to the municipal storm water system. Some of the original piping has been replaced with PVC piping. There are no secondary roof drains or strainers on the existing roof drains. Domed strainers should be added to the roof drains to keep debris out of the storm water system.

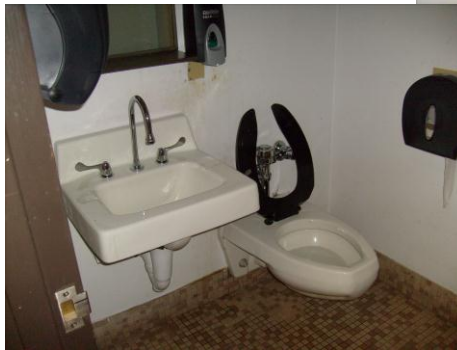
- Water closets are floor or wall mounted; flush valve, vitreous china. Some of the fixtures have been replaced with water conserving fixtures with sensor operated flush valves. The fixtures range from original to the facility in fair condition to new in very good condition. The original fixtures are non-water conserving type and non-ADA compliant.

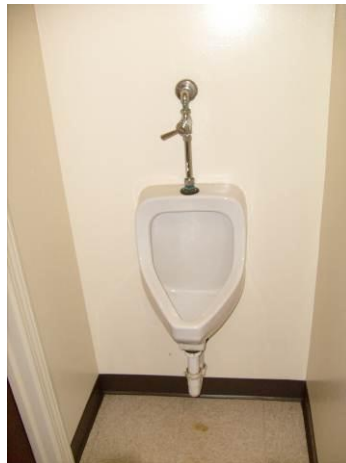
- Urinals are wall hung, vitreous china, with flush valves. The fixtures are original to the facility in fair condition, non-water conserving type and non-ADA compliant.

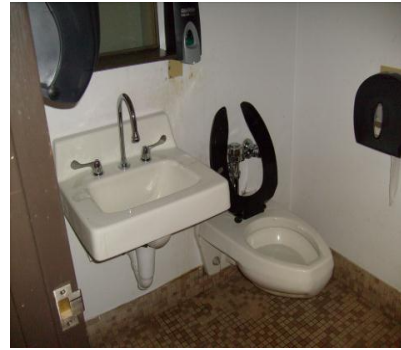
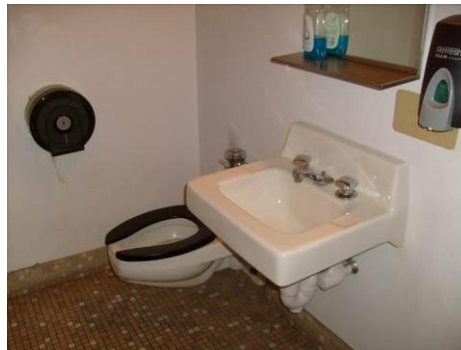
- Lavatories are wall hung vitreous china. Some of the fixtures have been replaced with water conserving fixtures with sensor operated faucets. The original fixtures have two lever handle faucets. The fixtures range from original to the facility in fair condition to new in very good condition. The original fixtures are non-water conserving type and the faucets and drains are non-ADA compliant.

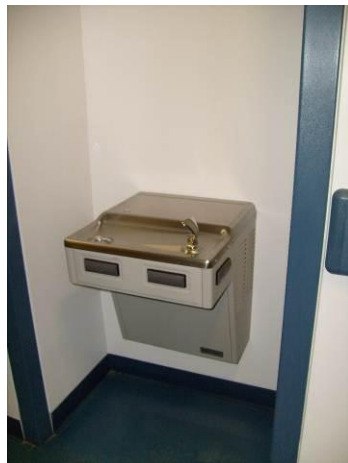
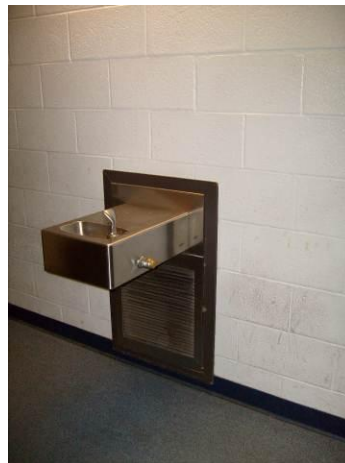
- Drinking fountains are wall mounted stainless steel units in good condition. The amount these units protrude into the path of travel should be reviewed for compliance with current ADA requirements.

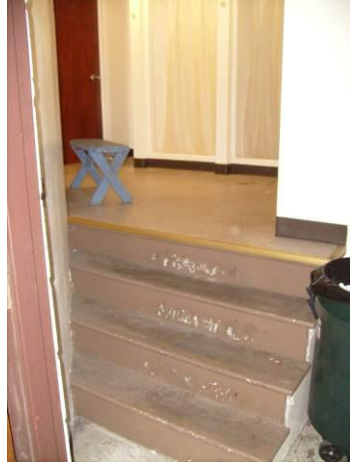
- In the Police Headquarters, there is a single shower located in the lower level training room, up a small flight of stairs. This shower is a fiberglass unit and in good condition. The location of this shower is not ADA accessible.

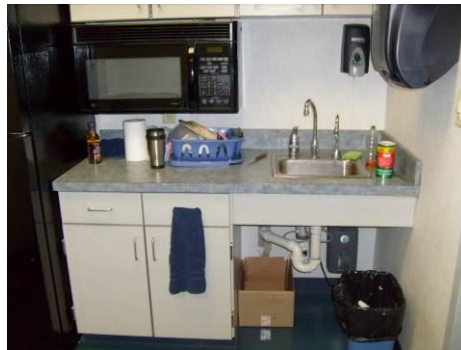
- Stainless steel sink with two lever gooseneck type faucet is present in a work/break room. This sink is ADA compliant and in good condition.

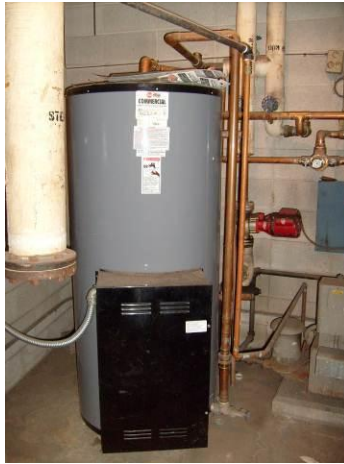
1. The existing domestic hot water system includes a Ruud Model ES120-36-G electric hot water heater. This equipment is in very good condition.

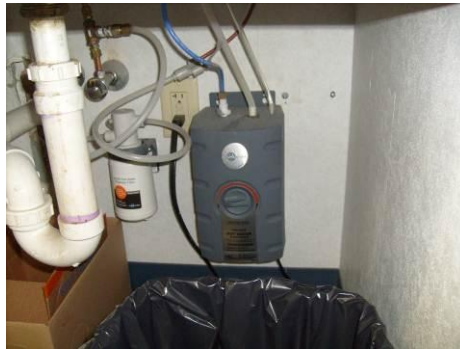
2. A local instantaneous electric water heater has been installed below a sink in a break room in the Police Department. This equipment is in good condition.

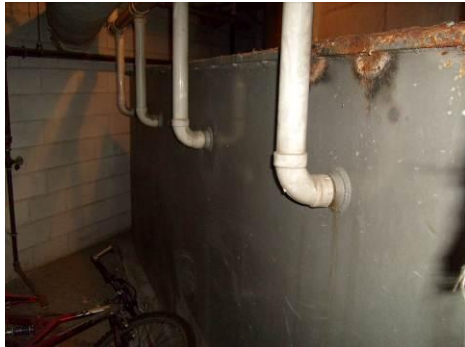
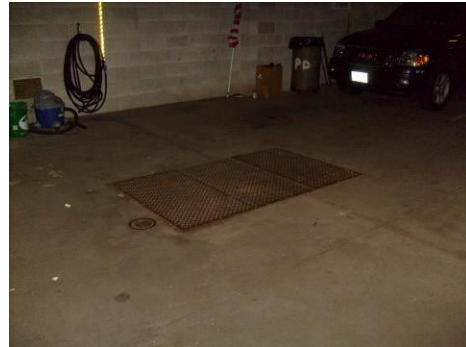
3. There are oil/water separators located in the parking garage. (1) is located above grade and one is located in the floor of the lower level. This equipment is original to the facility and in poor condition.

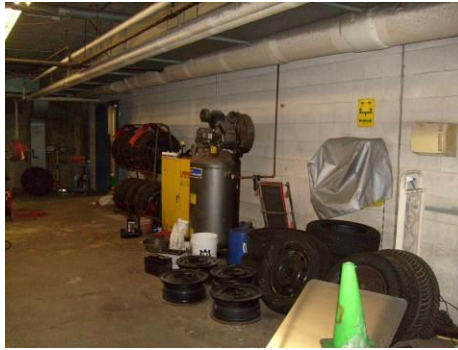
4. There is an air compressor system consisting of a vertical air compressor, piping and outlets located in a maintenance area serving the Police Department. This equipment is in fair condition.

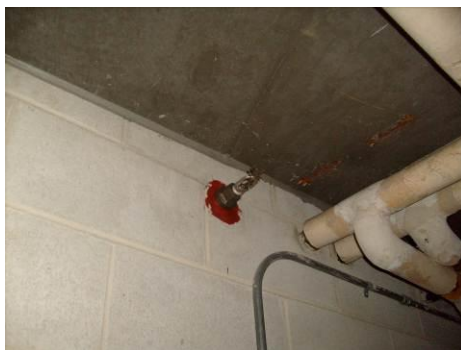
1. The building is served by a 6" fire protection service fed from a fire main in North Main Street. This fire service includes a shut-off valve and Watts Model 774 double check valve. The buildings are protected throughout with a full sprinkler system. There are also standpipes located in the stairs. This backflow preventer equipment has been recently installed and is in good condition. The remainder of the piping and most of the sprinkler heads are original to the building. The sprinkler heads and fire protection piping in the Police Headquarters was modified during the last renovation.

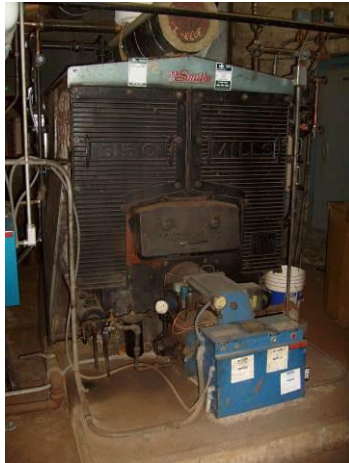
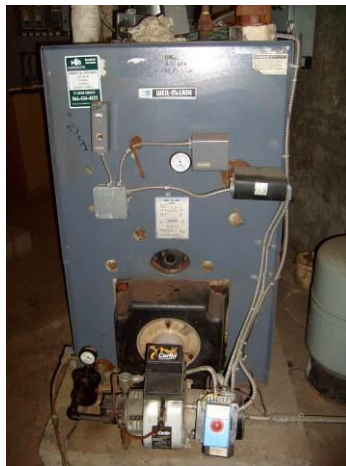
1. The existing building is heated by (2) H.B. Smith 350 Mills, 13-section oil fired steam boilers with Power Flame Model C30-04HBS-10-14 oil burners. There is a separate oil fired boiler that serves the cell block area. It is a Weil McClain Series 78, Model 478 hot water boiler with a Carlin Model 201 CRD-w oil burner. The H.B. Smith boilers, burners, and breeching are original to the building and in poor condition. The Weil McClain equipment is newer and in good condition.

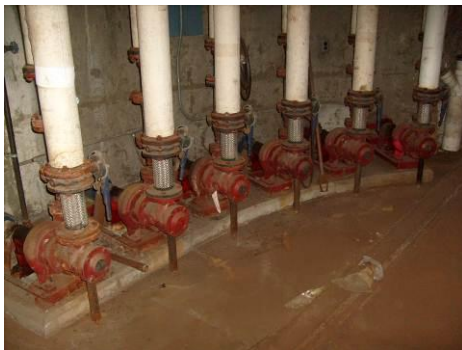
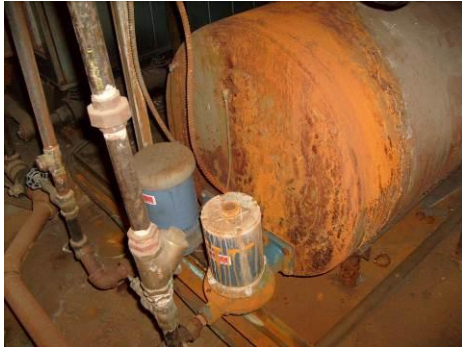
2. The heating plant also includes a condensate receiver, boiler feed system, hot water heat exchanger, condensate receivers, and hot water pumps. All of this equipment is original to the facility and poor condition.

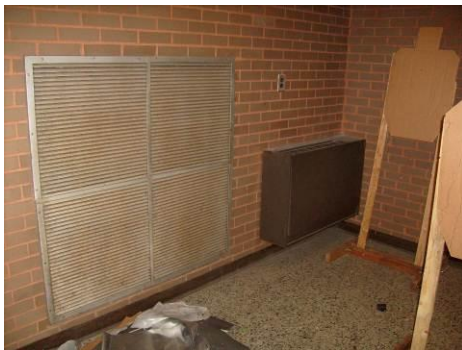
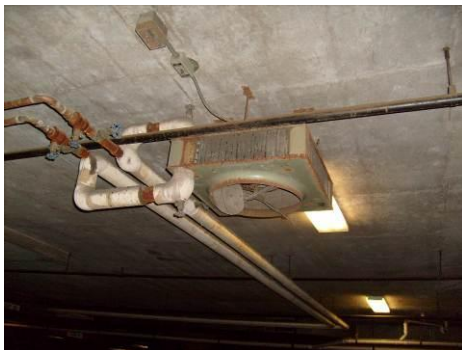
3. The present heating system also includes cabinet unit heaters, and ceiling mounted unit heaters and steam coils in the air handling equipment. This equipment is original to the building and in poor condition.

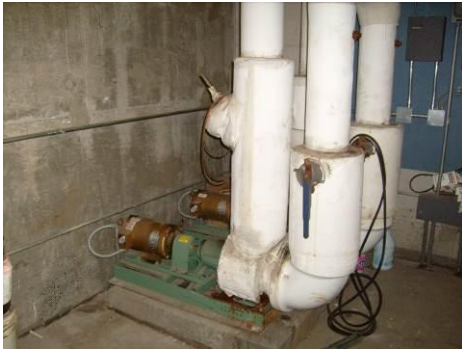
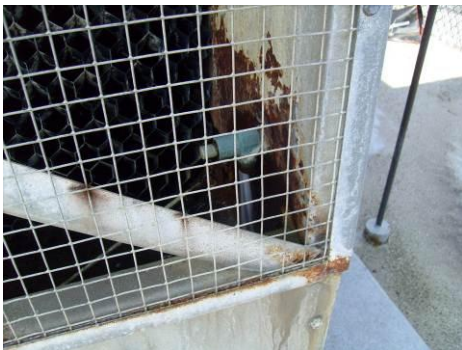
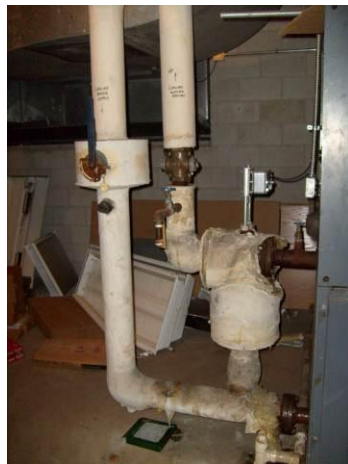
4. The air conditioning system consists of a Trane Series R Centravac chiller, Model RTHB150FMCOONW0000UNN3LF2LF00QU chiller installed in 1996. This chiller is shared between the two buildings. The chiller is in good condition. There is a cooling tower mounted on the roof of the parking facility that is in very poor condition. This piece of equipment has significant corrosion problems and the maintenance staff has made many attempts to repair this sump which has allowed this unit to operate.

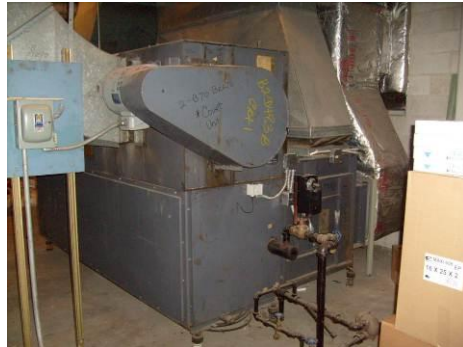
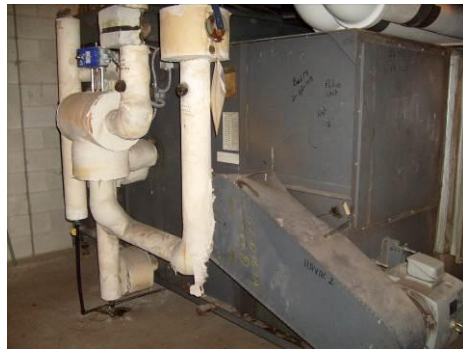
5. The air handling equipment is Trane Climate Changer units that serve as heating and air conditioning units or air conditioning units only. There are also large exhaust/return air fans. This equipment is located in mechanical rooms within the buildings and are original to the facility and in poor condition.

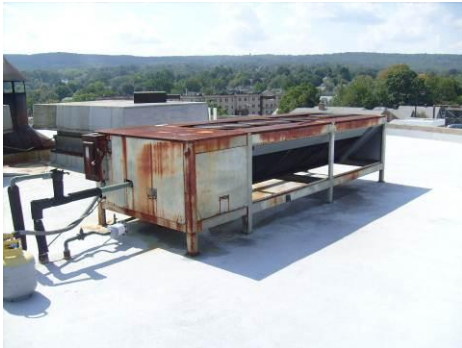
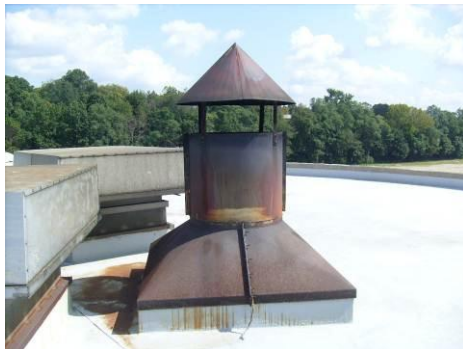
7. The roof mounted equipment consists of exhaust fans, condensing units, etc. This equipment is original to the building and in poor condition.

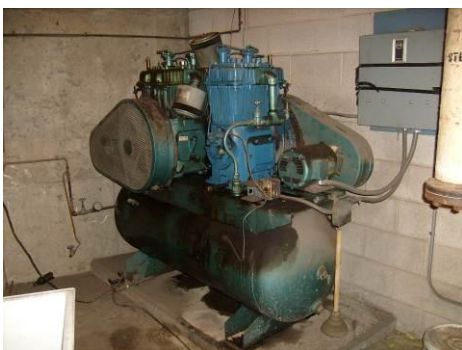
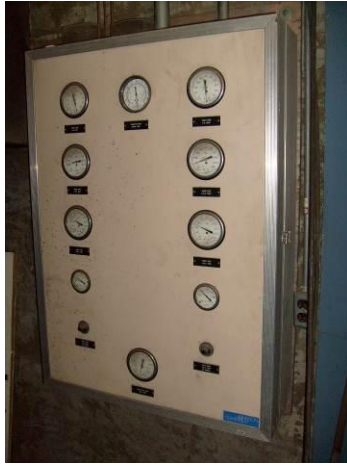
8. The existing temperature control system consists of a pneumatic system by Johnson Controls. This includes an air compressor, air dryer, control panels and pneumatic tubing. Some of the control valves have been replaced as needed. The remainder of the equipment is original to the building and in poor condition.

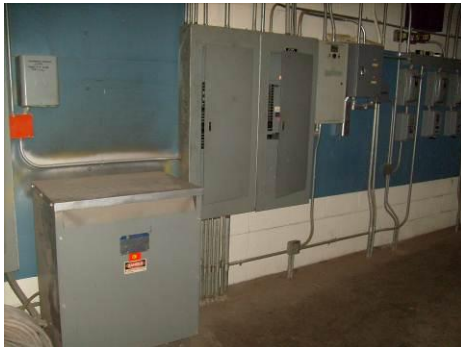
2. There are a number of electrical panels located throughout the facility. Some of these panels are original to the facility and some have been replaced with new. There are a number of panelboards located in storage rooms that have material stored in front of them which is a code violation. In addition, there is one panelboard that has had a significant water leak above it. The conduit, boxes, and panel are showing signs of corrosion. The condition of the panelboards ranges from poor to good.

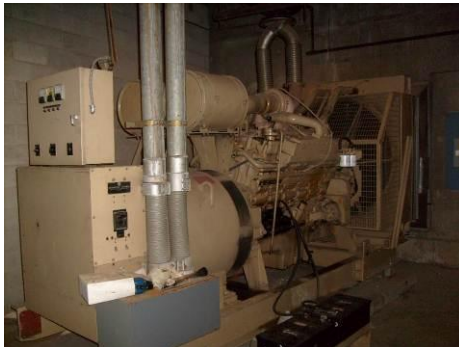
3. The building is served by a Cummings Model 080FDR5057A8W, 410kW, 613kVA diesel generator. The generator is located in the main electrical room. The transfer switch is located in the main electrical switchboard. There is a separate day tank (fuel tank) that pumps fuel oil from the exterior underground tank to feed the emergency generator. To meet current codes, (2) separate automatic transfer switches would be required to separate life safety from other loads in the building. This generator and associated equipment is original to the facility and in good condition.

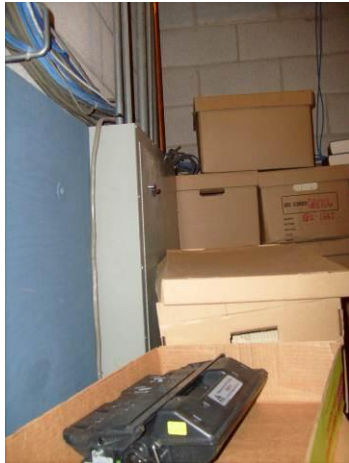
4. In the Main Electrical Room there is a series of (91) wet-cell batteries that serve as back-up power to emergency lighting and other pieces of equipment between when normal utility power is lost and the emergency generator starts. It is controlled by a Dual

Lite Model 120-120-S-791 charger. There is also a number of Dual Lite control panels located throughout the building. Some of these control panels are inaccessible because of items stored in front of them. This equipment is original to the facility and in fair condition. To satisfy current codes, this equipment is required to be in a separate room with adequate ventilation, etc.

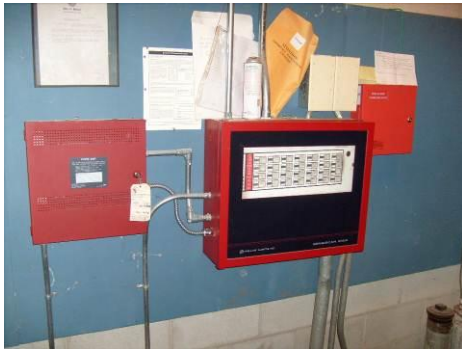
6. The fire alarm system is manufactured by Fire Lite, Model Sensiscan 2000 or Simplex. The system includes control panels, manual pull stations, horn-strobes, and some smoke detectors. This system is in fair condition and portions are non-ADA compliant. Additional audio visual devices should be added to the building as well as upgrading to an addressable ADA-compliant system.

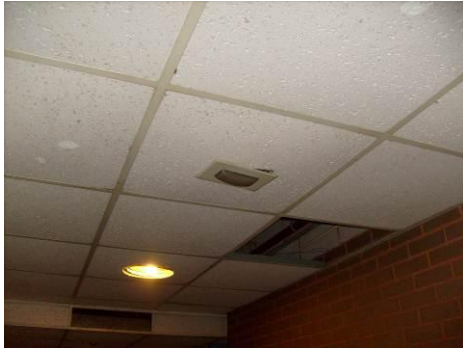
7. The emergency lighting is provided by a Dual Lite Inverter System that includes the inverter, batteries, ceiling mounted remote heads and controls. Although this system is operational, it is in poor condition. Additional lighting fixtures are required to meet current requirements for emergency lighting.

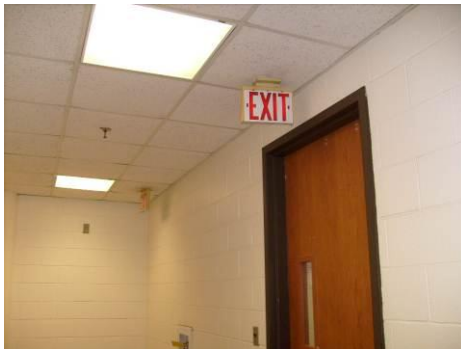
8. The exit signs consist of fluorescent exit signs with batteries. This equipment is in fair condition. Additional exit signs are required to meet current requirements for exit signs.

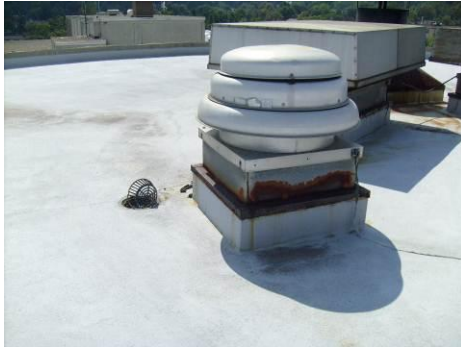
- a. There is a lightning protection system installed at the facility. It appears that during recent roof work, some of the lightning protection system was disconnected. This should be repaired to maintain the integrity and operation of the system.

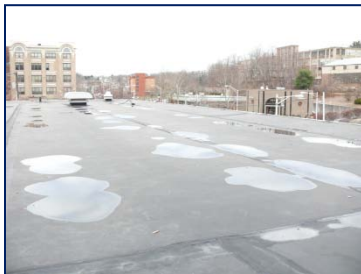
Roof: The roof is a dead-level, mechanically fastened E.P.D.M. system approximately 15 years old. Rainwater ponds on the surface of the roof. The roof should be modified to reduce the amount of ponding and provide positive drainage to the roof drains. If building modifications occur it is recommended that a white roof be installed to reduce energy load.

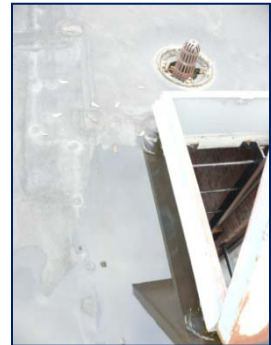
Roof access is by a permanent ladder in one of the stairs. An extension railing should be provided to the ladder and a guardrail added to the roof hatch.

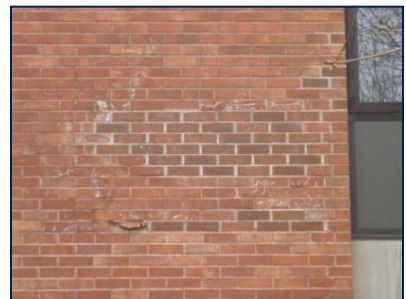
It appears that in the past, the roof has leaked into the walls causing efflorescence on the interior (noticeable in stair enclosures) and severe rusting of the shelf angle. There has also been extensive damage to the

brick including cracking, spalling and shifting. There is a strong possibility that wall ties in the wall may have corroded and failed. Some limited re-pointing and brick replacement has occurred. Also, as evidenced on the interior, there are vertical cracks at some locations where perpendicular walls intersect the exterior wall indicating that the wall is separating from the building.

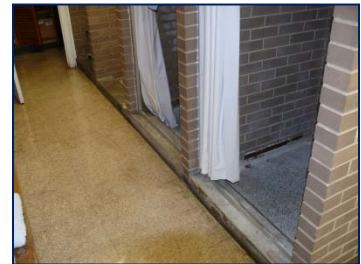
In general the finishes are in good condition but there are some areas of concern. In particular the toilet rooms and showers are constructed with brick. We consider this to be an unsanitary condition as it is very difficult to clean and is porous in nature. Evidence also exists, on the underside of the second floor in the apparatus room that the showers have been leaking.

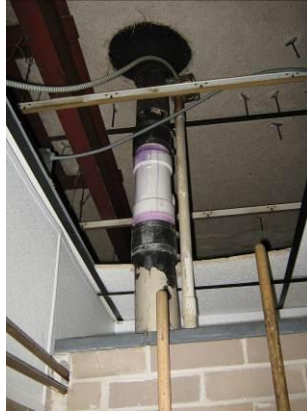
- a. The storm piping is primarily cast iron and drains to the municipal storm water system. There are no secondary roof drains.
- b. There are areas of the storm water system where the piping has been replaced with PVC. Further investigation should be done to determine the exact cause of the failure.

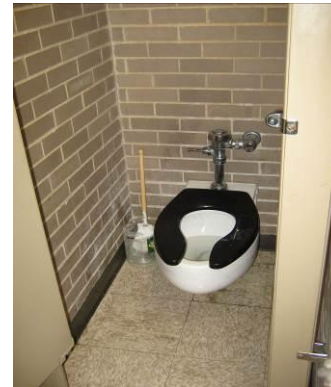
- Water closets are floor or wall mounted; flush valve, vitreous china. These fixtures are non-water conserving type in fair condition. Most of these fixtures are non-ADA compliant.

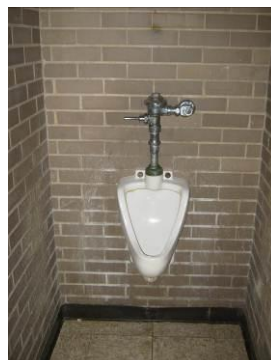
- Urinals are wall hung, vitreous china, with flush valves. These are non-water conserving type and in fair condition.

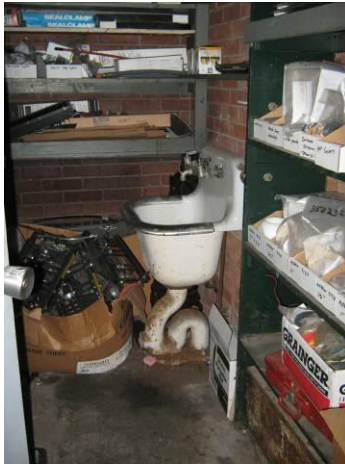
- Janitor sinks are wall mounted cast iron units with two lever faucets. There is no vacuum breaker present at these sinks. The sinks are original to the building and in poor condition.

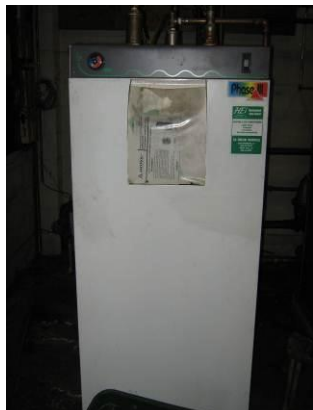
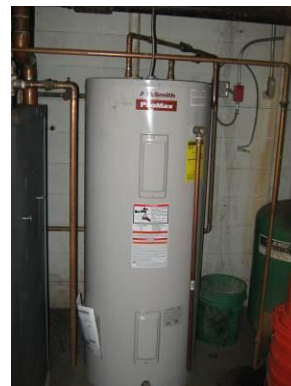
1. The existing domestic hot water system includes a Triangle Phase III indirect water heater which is fed from the existing boiler. The system also includes an A.O. Smith Model ECT 80-200 electric water heater. This equipment is in fair to good condition.

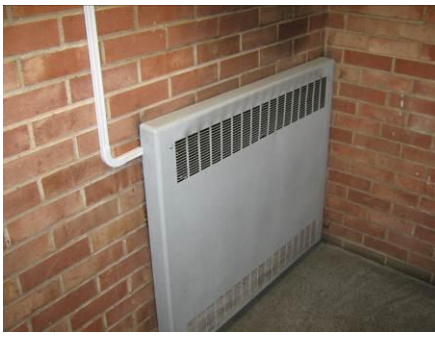
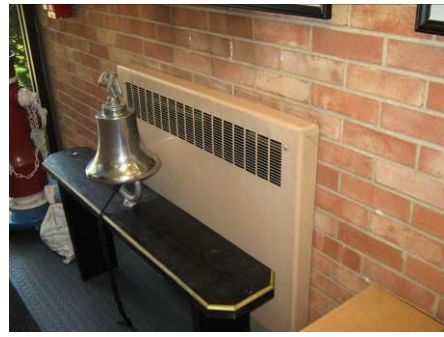
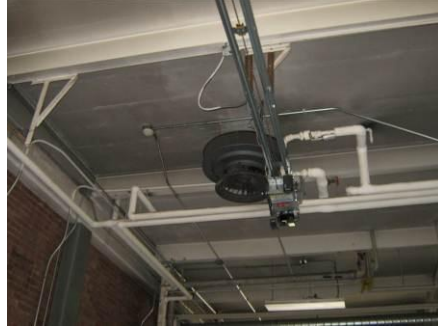
3. The present heating system also includes hot water cabinet unit heaters and baseboard radiators in the occupied areas of the building. Ceiling mounted fan powered unit heaters are located in the apparatus bays.

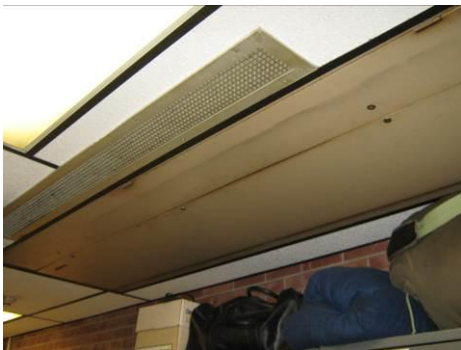
4. There are ceiling mounted fan coil units with supply air ductwork, ceiling mounted supply air diffusers, a single return, and remote condensing units for air conditioning. There are complaints from the occupants because of poor air distribution from these units. This equipment is in poor condition.

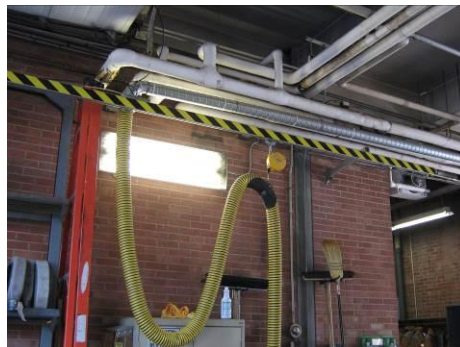
5. Toilet exhaust fans are located on the roof. This equipment is in poor condition.
6. The apparatus bays include a vehicle exhaust removal system manufactured by Plymovent. This includes flexible air hoses connected to the apparatus, support rails for the flexible hose, exhaust ductwork, fans and controls. This equipment is in good condition.

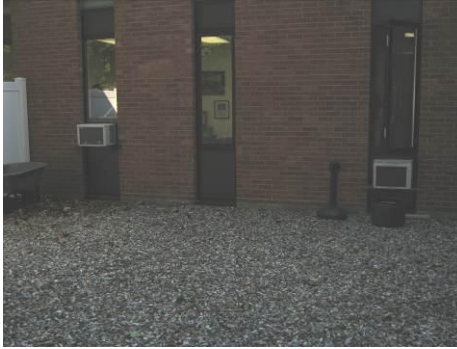
7. Window type air conditioning units have been added to supplement the overhead distribution system.

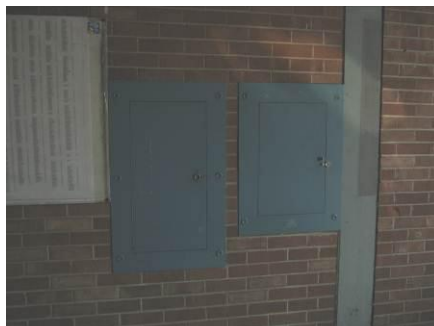
2. There are a number of electrical panels located throughout the facility. These panelboards are original to the facility. The condition of these panelboards is fair. The majority of the panelboards do not have spare circuit breakers available for new circuits to be added, or have space to add new circuit breakers.

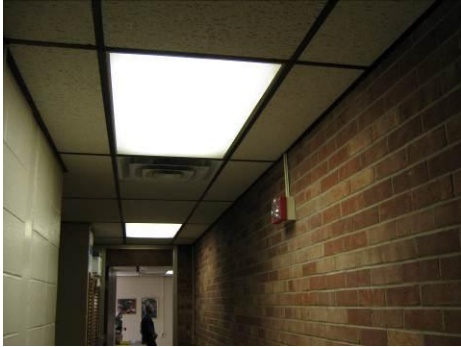
3. The lighting throughout the facility consists primarily of recessed mounted acrylic lensed fluorescent fixtures in the occupied spaces and industrial fluorescent fixtures in the apparatus bays and storage areas. There are other miscellaneous fixtures spotted throughout the building. Most of the lighting is older T12 technology and should be upgraded. There are other fixtures using incandescent lamps that are in poor condition that should be replaced. There are also other fixtures that are damaged that should be replaced. The lighting ranges from poor to fair condition.

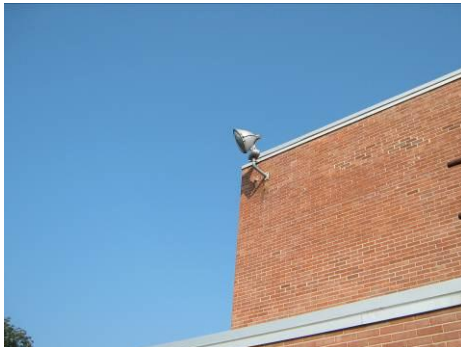
4. Site lighting is limited and consists of building mounted flood lights. These fixtures are not energy efficient and are in poor condition.

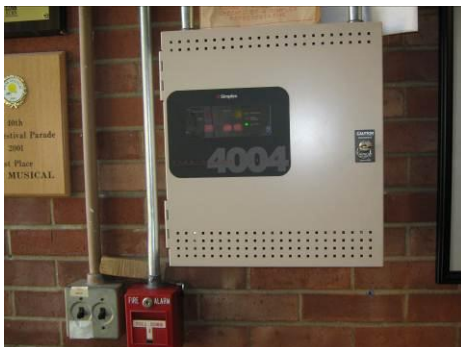
5. The fire alarm system is manufactured by Simplex, Model 4004. The system includes manual pull stations, horn strobes, and ceiling mounted smoke or heat detectors. This system is in good condition. The coverage of smoke detectors and other devices appear to be inadequate. Additional devices, such as horn/strobe units, are required to comply with current ADA requirements.

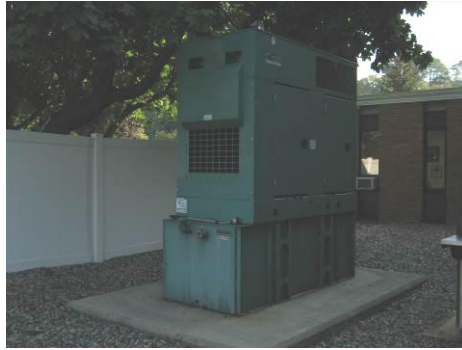
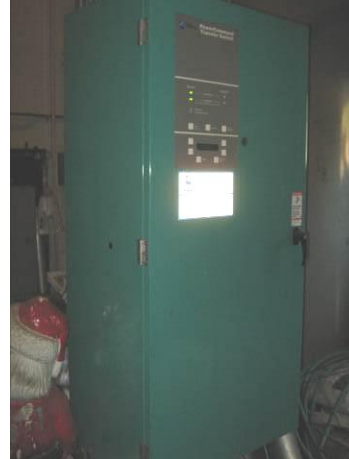
7. The emergency lighting is provided by the emergency generator. This emergency generator serves the entire facility. The emergency generator consists of an external generator manufactured by Cummins/Onan, weatherproof enclosure, base mounted fuel tank, and 400amp automatic transfer switch. This equipment is in very good condition.

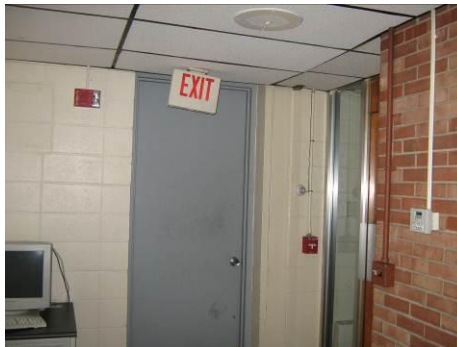
8. The exit signs consist of fluorescent exit signs, some including batteries. This equipment is in fair condition.
