Town of Newtown

Facilities Assessment Report

AUGUST 24, 2015

NEWTOWN FACILITIES CONDITION ASSESSMENT REPORT

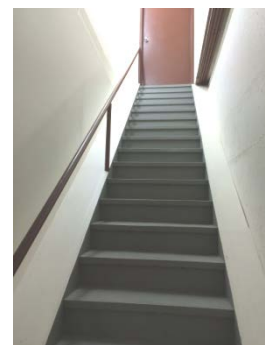
2

Stair between Lower and Upper Levels has projecting nosings and only one handrail. There is also insufficient landing space at the bottom and top of the stair. This stair appears to be a service stair that is not used by other than the custodial staff but it does serve as an egress from what would otherwise be a dead end corridor. As such the stair needs to be upgraded to remove the projecting nosings by using beveled siding to create a gradual slope from the treads to the nosings. ADA compliant handrails need to be added on both sides. The bottom landing will need to be increased in size to allow for clearance space at the door. Similarly, the door at the top of the stair needs to be removed

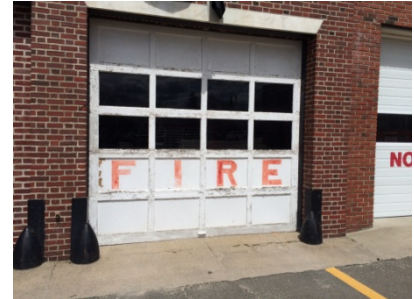
3

All wood windows, doors, overhead doors, plywood panels and wood trim have areas of peeling paint and bare wood is visible. Scrape paint down to solid material, and feather edges. Fill wood splits and holes. Repaint with a primer and two coats. Verify proper operation of all windows and doors and make necessary adjustments.

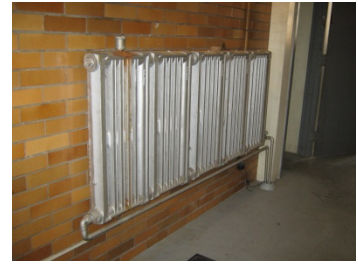
The hot water system serves unit heaters and cast iron radiators. The unit heaters are in good condition, the cast iron radiators are most original to the building and nearing the end of their useful life.

Recommend replacing cast iron radiators with fin tube radiation, Install air handling systems to provide mechanical ventilation. Install central air condition systems through new ducted units and/or ductless split AC units. Replace and upgrade controls to web based DDC type system.

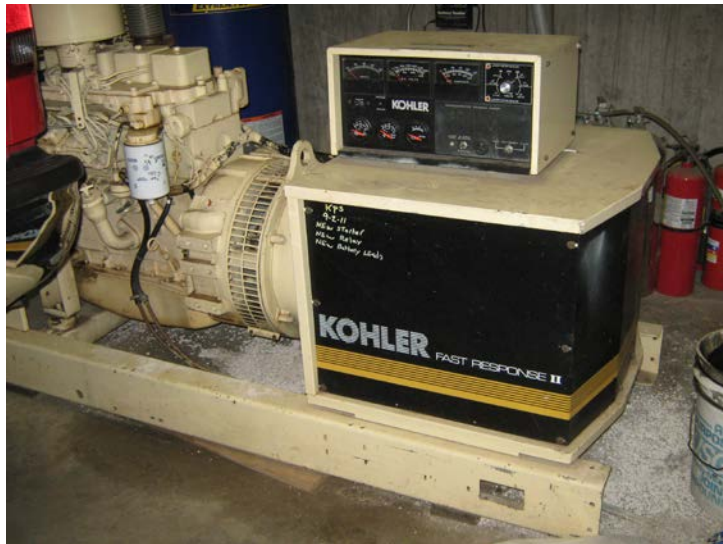
1. The building is served by General Electric distribution panels, service rated at 200 amperes, 208Y/120 volts, 3-phase. The service equipment and main distribution panels are in good condition.
2. Emergency Generator: The generator is a 30 KW Kohler; fuel fired generator with day tank / pump set located inside the garage bay. The system is in fair condition.

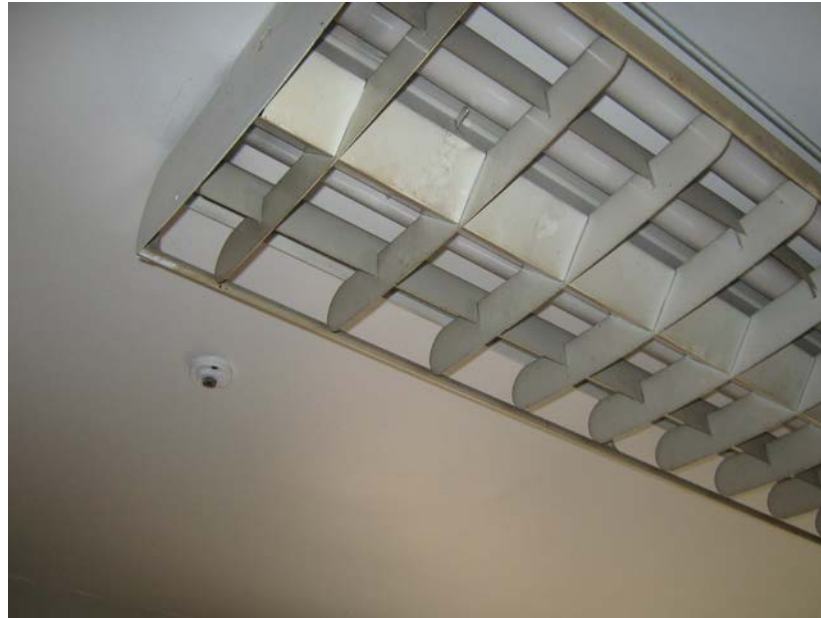
3. Lighting, in general, consists primarily of fixtures with T12 fluorescent lamps. Most of the fixtures are in poor condition and should be updated to more energy efficient lighting and controls. .

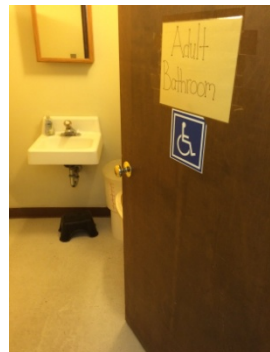
3

No ADA compliant restrooms. Neither the adult or the children's restrooms comply with ADA codes. Modify restroom to comply with all ADA codes.

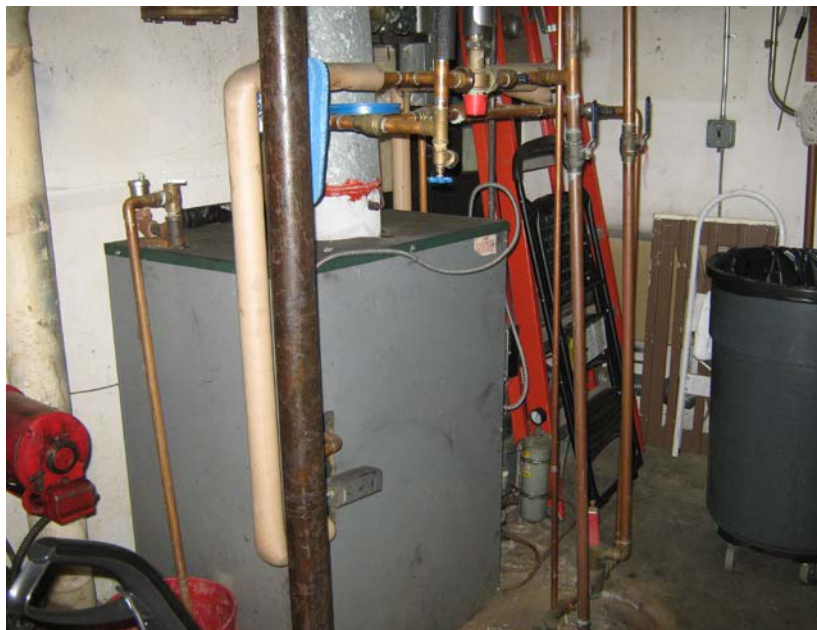
HOT WATER BOILER @ ORIGINAL BUILDING

1. Boiler Plant: Overall, the building is heated by two separate boilers which are not interconnected. Both boilers are fuel oil fired. The boiler at the original building is a Peerless Model STC-07 hot water boiler with nominal capacity of 400 MBH. This boiler, its pumps and related hydronic piping system is reaching the end of its useful life.

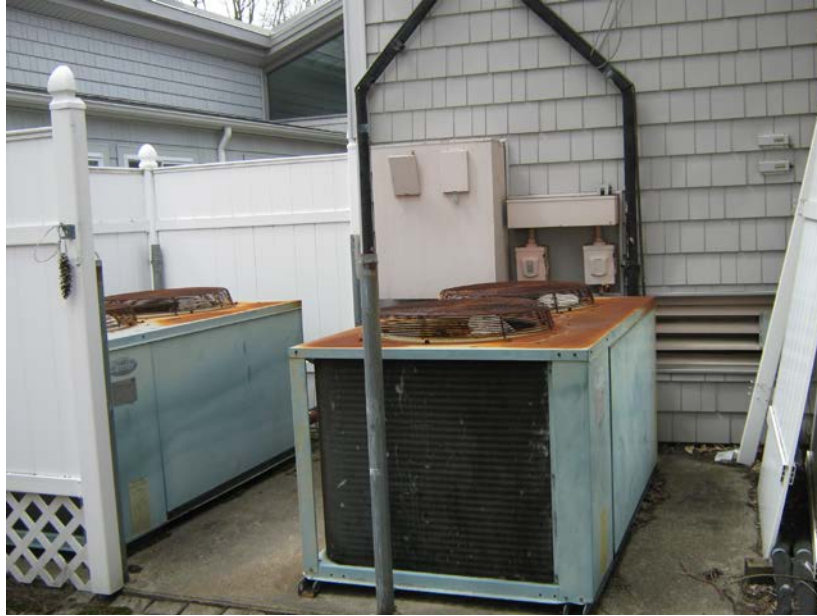
COMPRESSOR / CONDENSER @ ORIGINAL BUILDING

1. The buildings area served by indoor mounted air handling units with remote compressor / condensers located outside at grade. The two units at the original building are in fair to poor condition. The unit at the new building addition is in good conditions.
